Case Studies: The Perils of Poor Rim Joist Closure Construction

Introduction

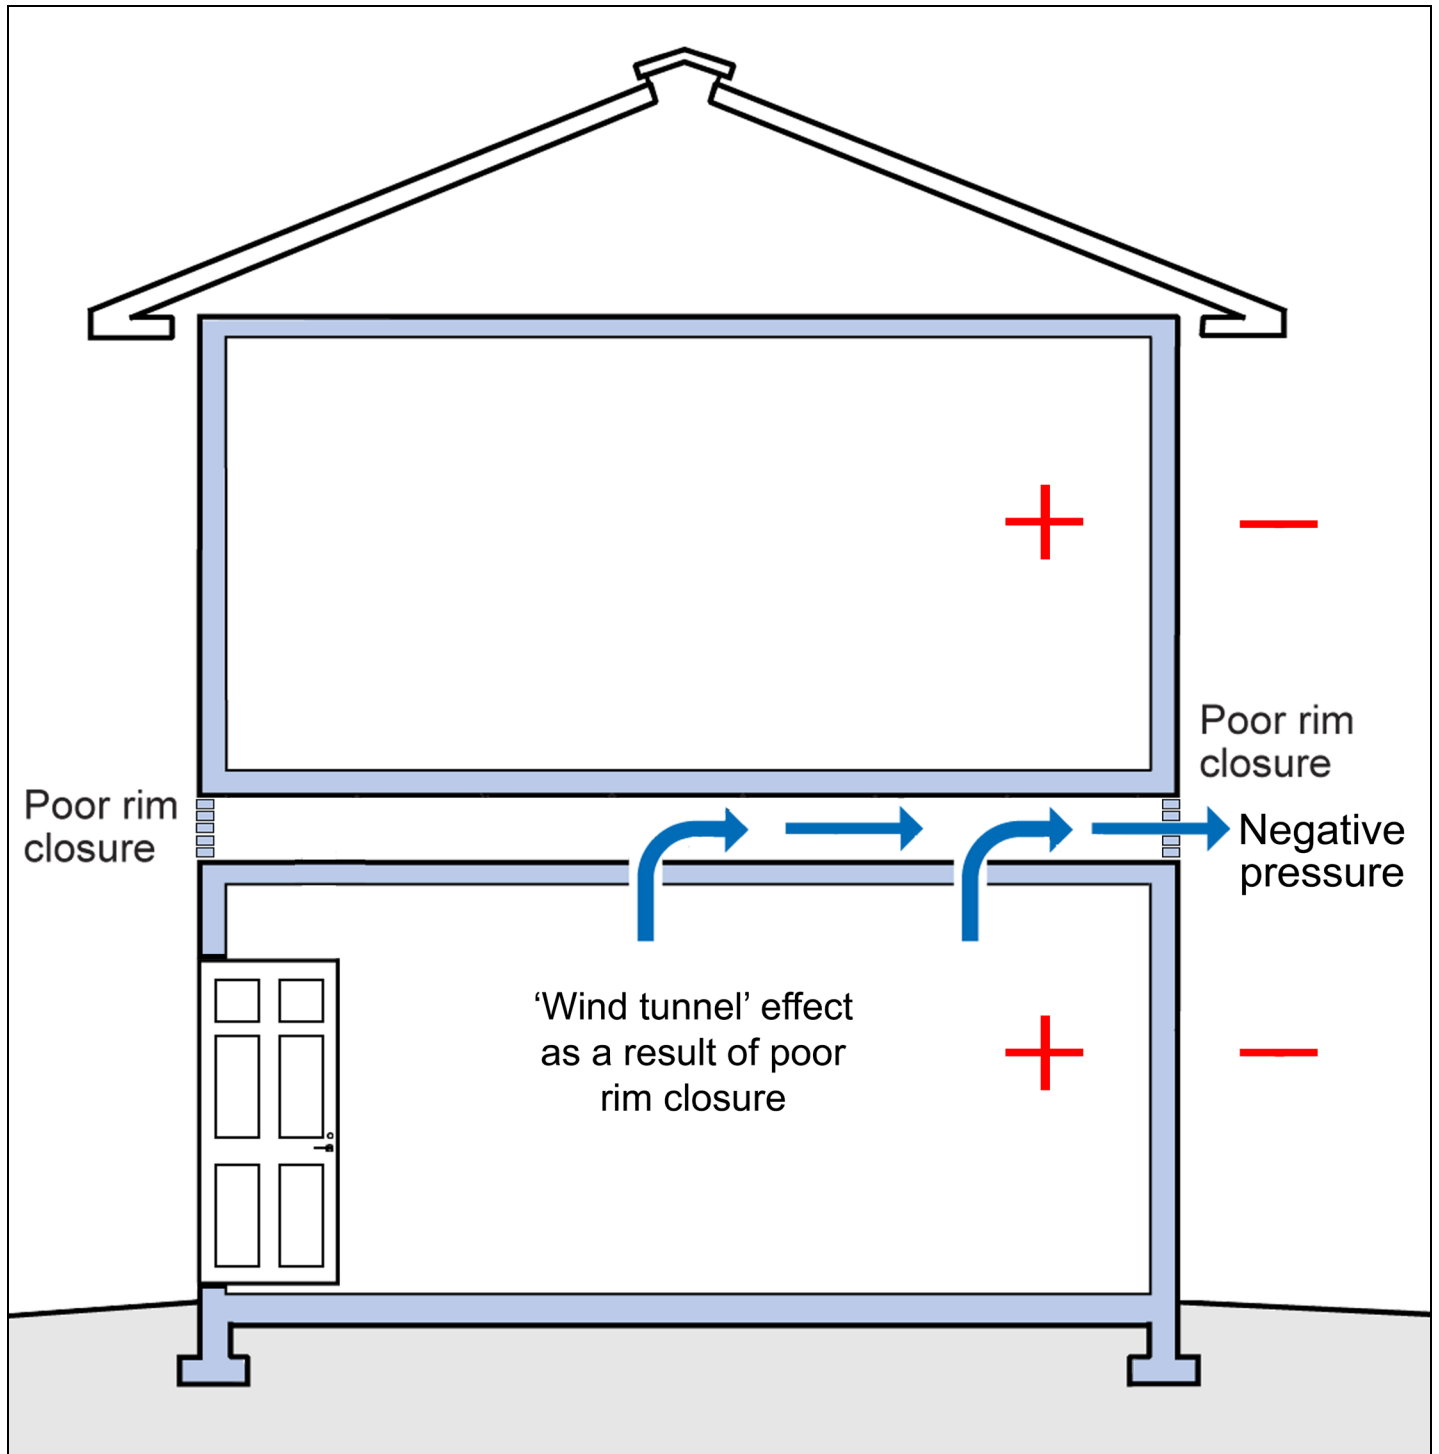
Figure 1 (closely derived from Dr. Lstiburek’s “Air Pressure” report) – When air pressure boundaries are not contiguous with building envelope thermal boundaries, pressure differentials readily can convey warm humid interior air to the colder back side of cladding/sheathing assemblies, causing highly damaging condensation and ensuing decay and degradation.

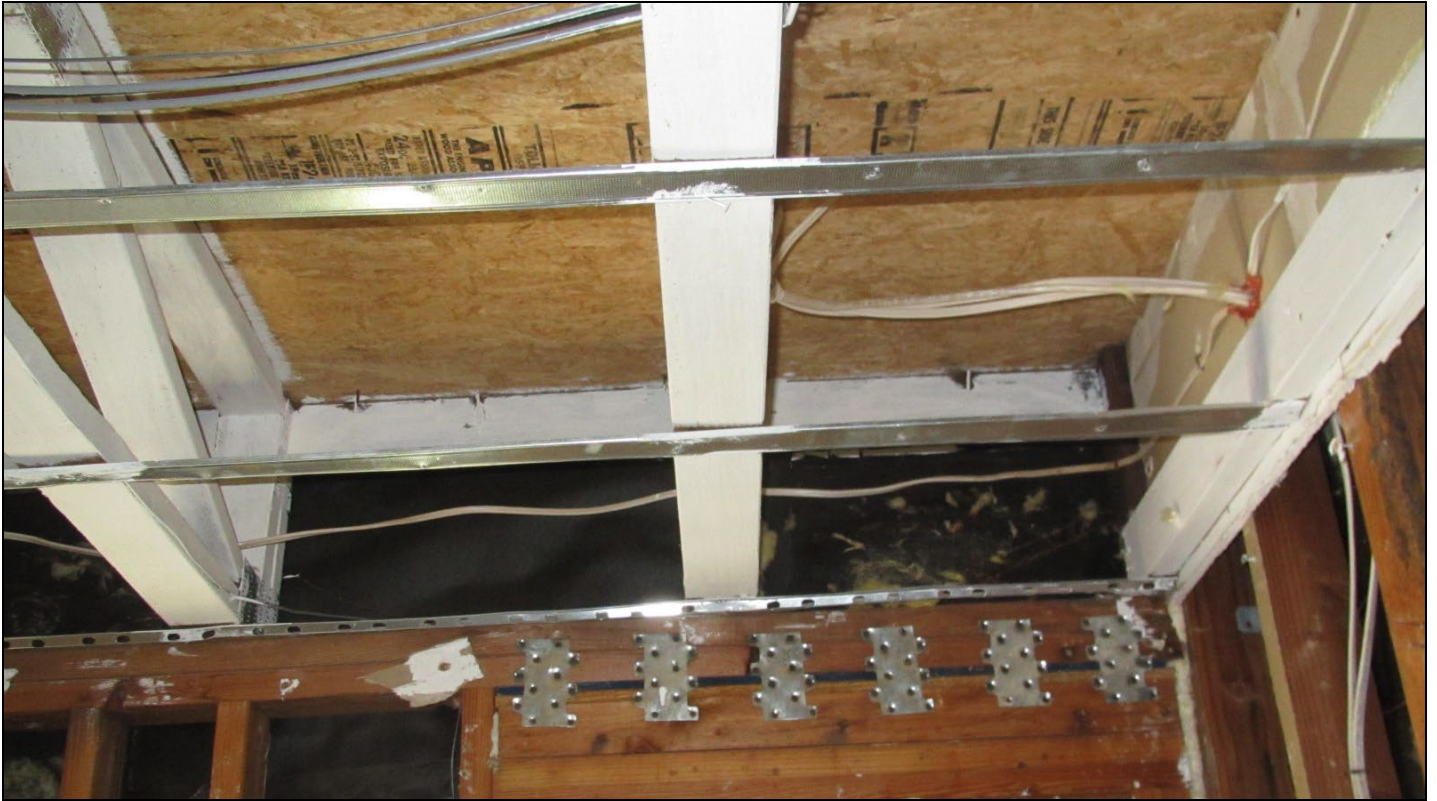
Photo 1 – No rim/band joist or exterior sheathing provided at the “open web” floor joists. Instead, upon insulation removal, we found the inside face of the asphaltic building paper serving the stucco cladding (installed over steel line wire per Photo 2).

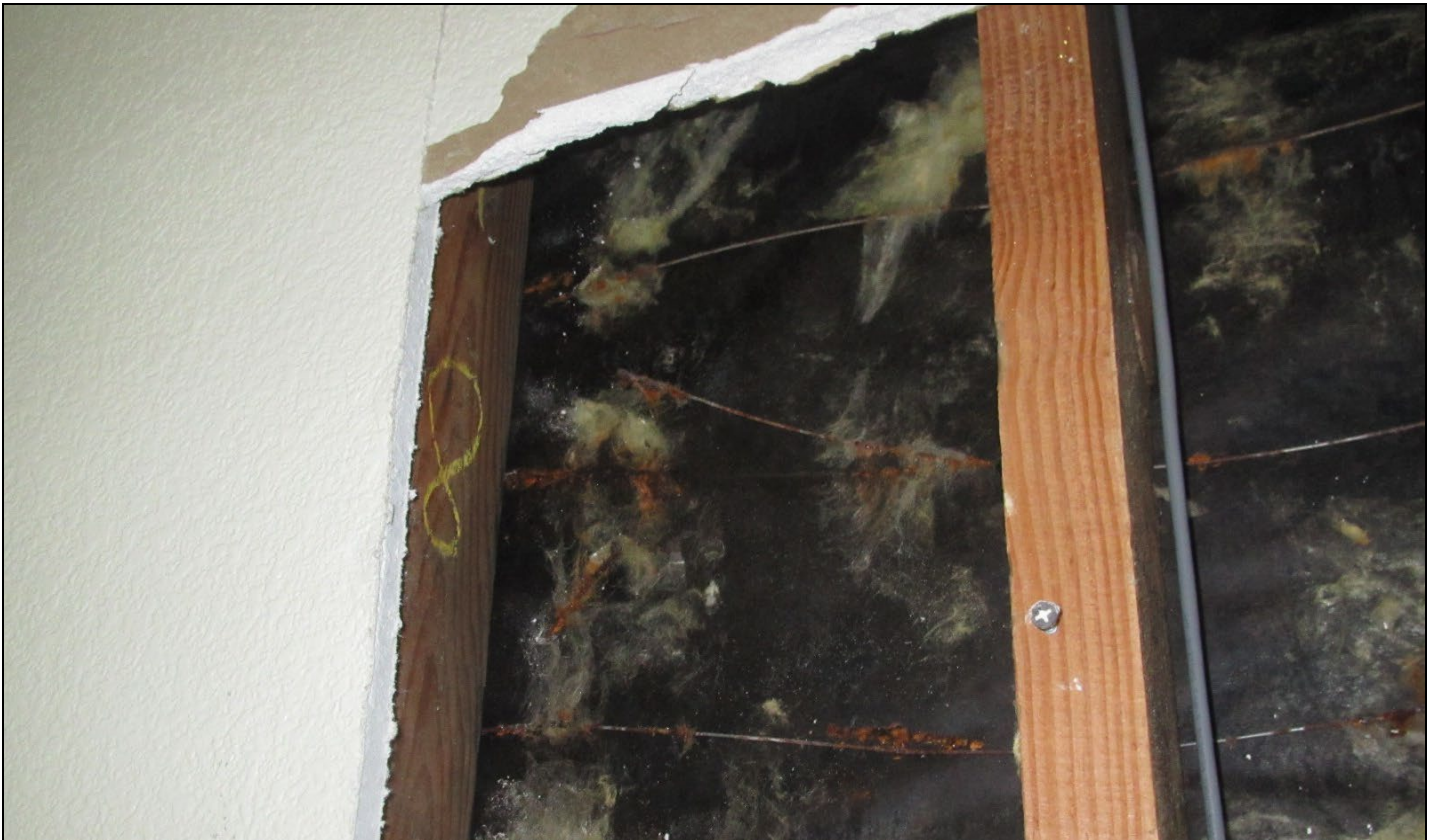
Photo 2 – The steel line wire that backed the stucco was extensively rusted and remnants of the fiberglass insulation remained stuck to the inside face of building paper. These conditions are consistent with condensation of warm humid interior air.

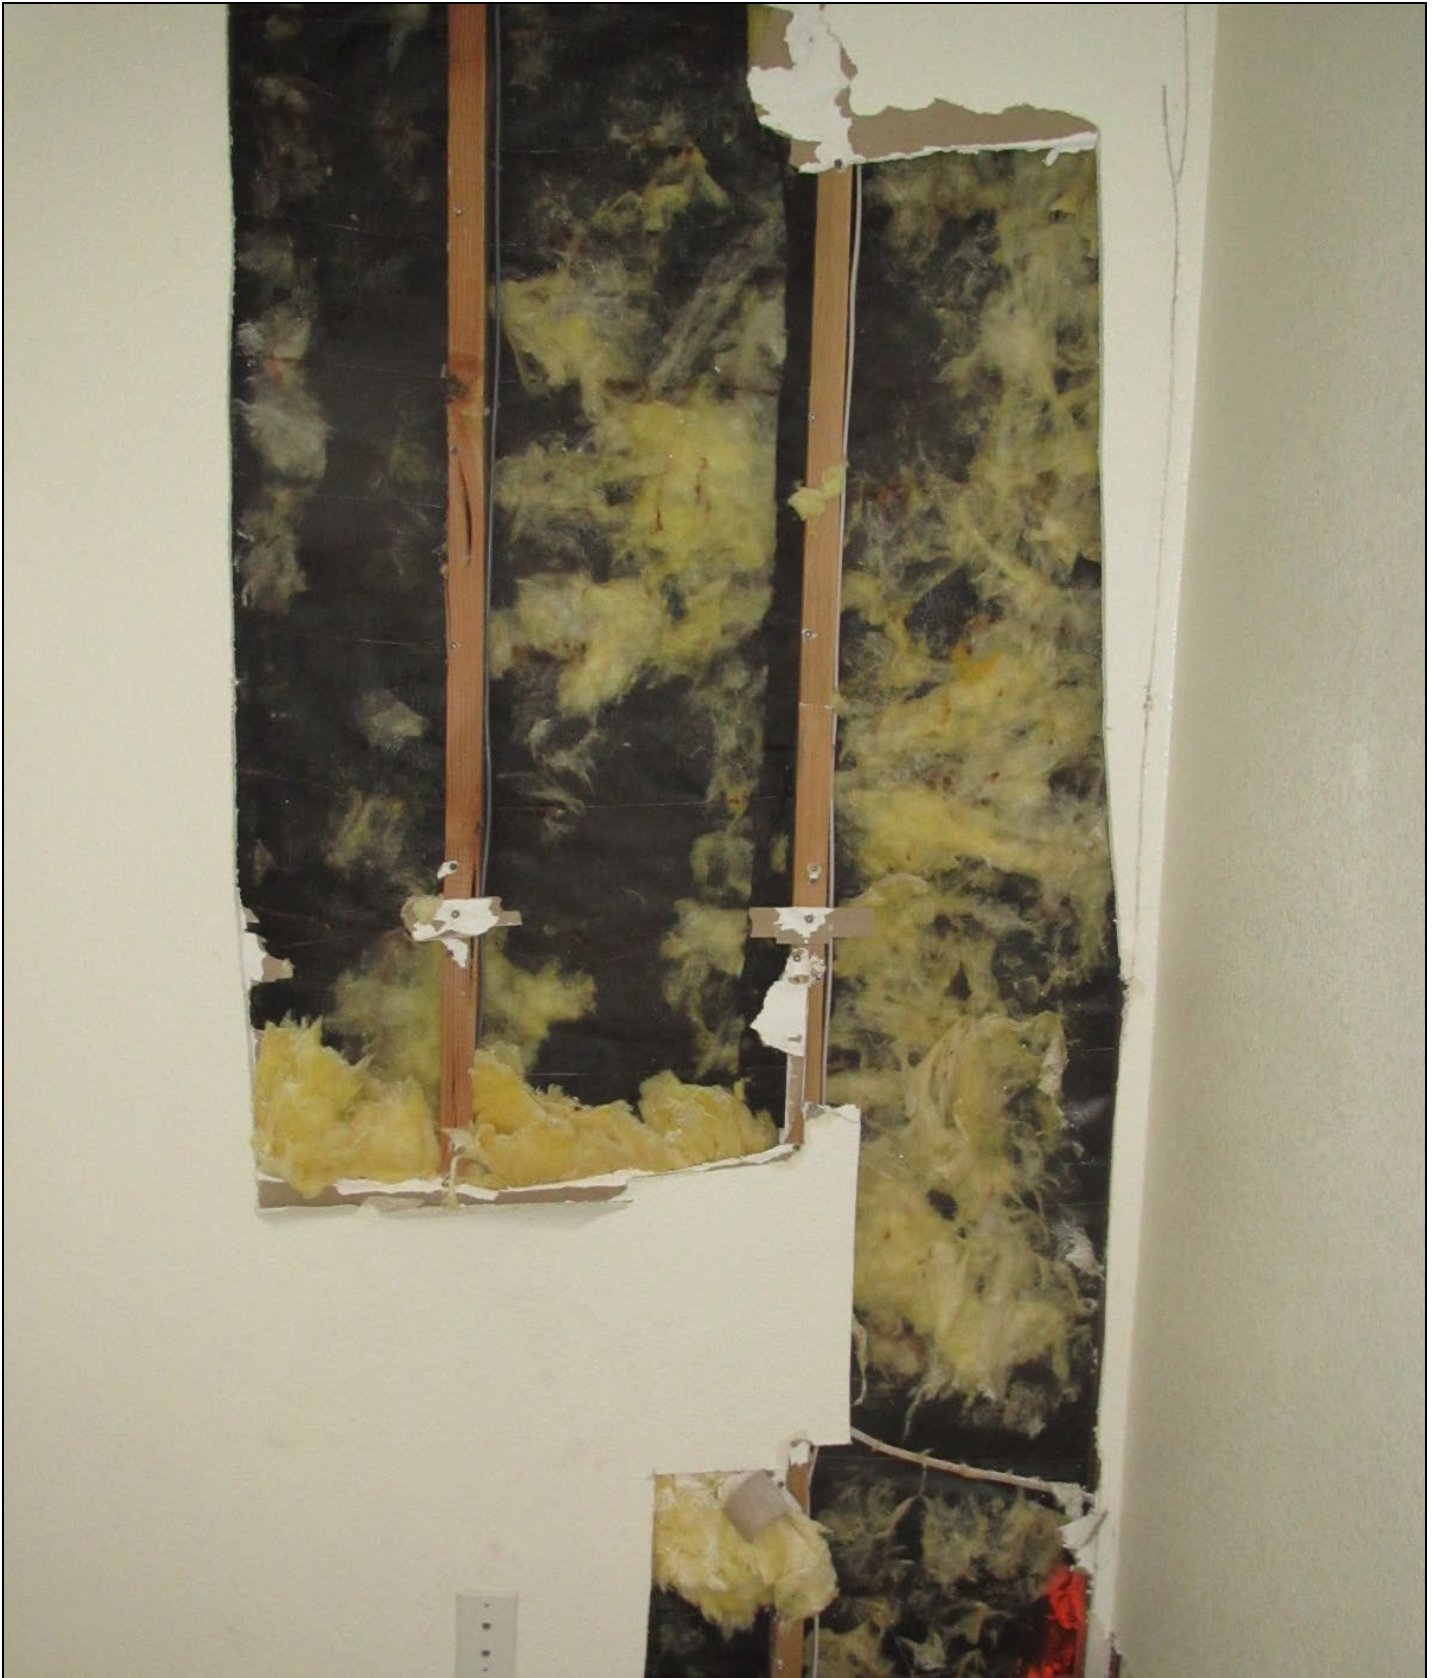
Photo 3 – These pervasive conditions (rusty line wire and remnants of the batt insulation stuck to the inside face of the building paper) indicated that the paper had been uniformly wet at times in a manner consistent with vapor condensation.

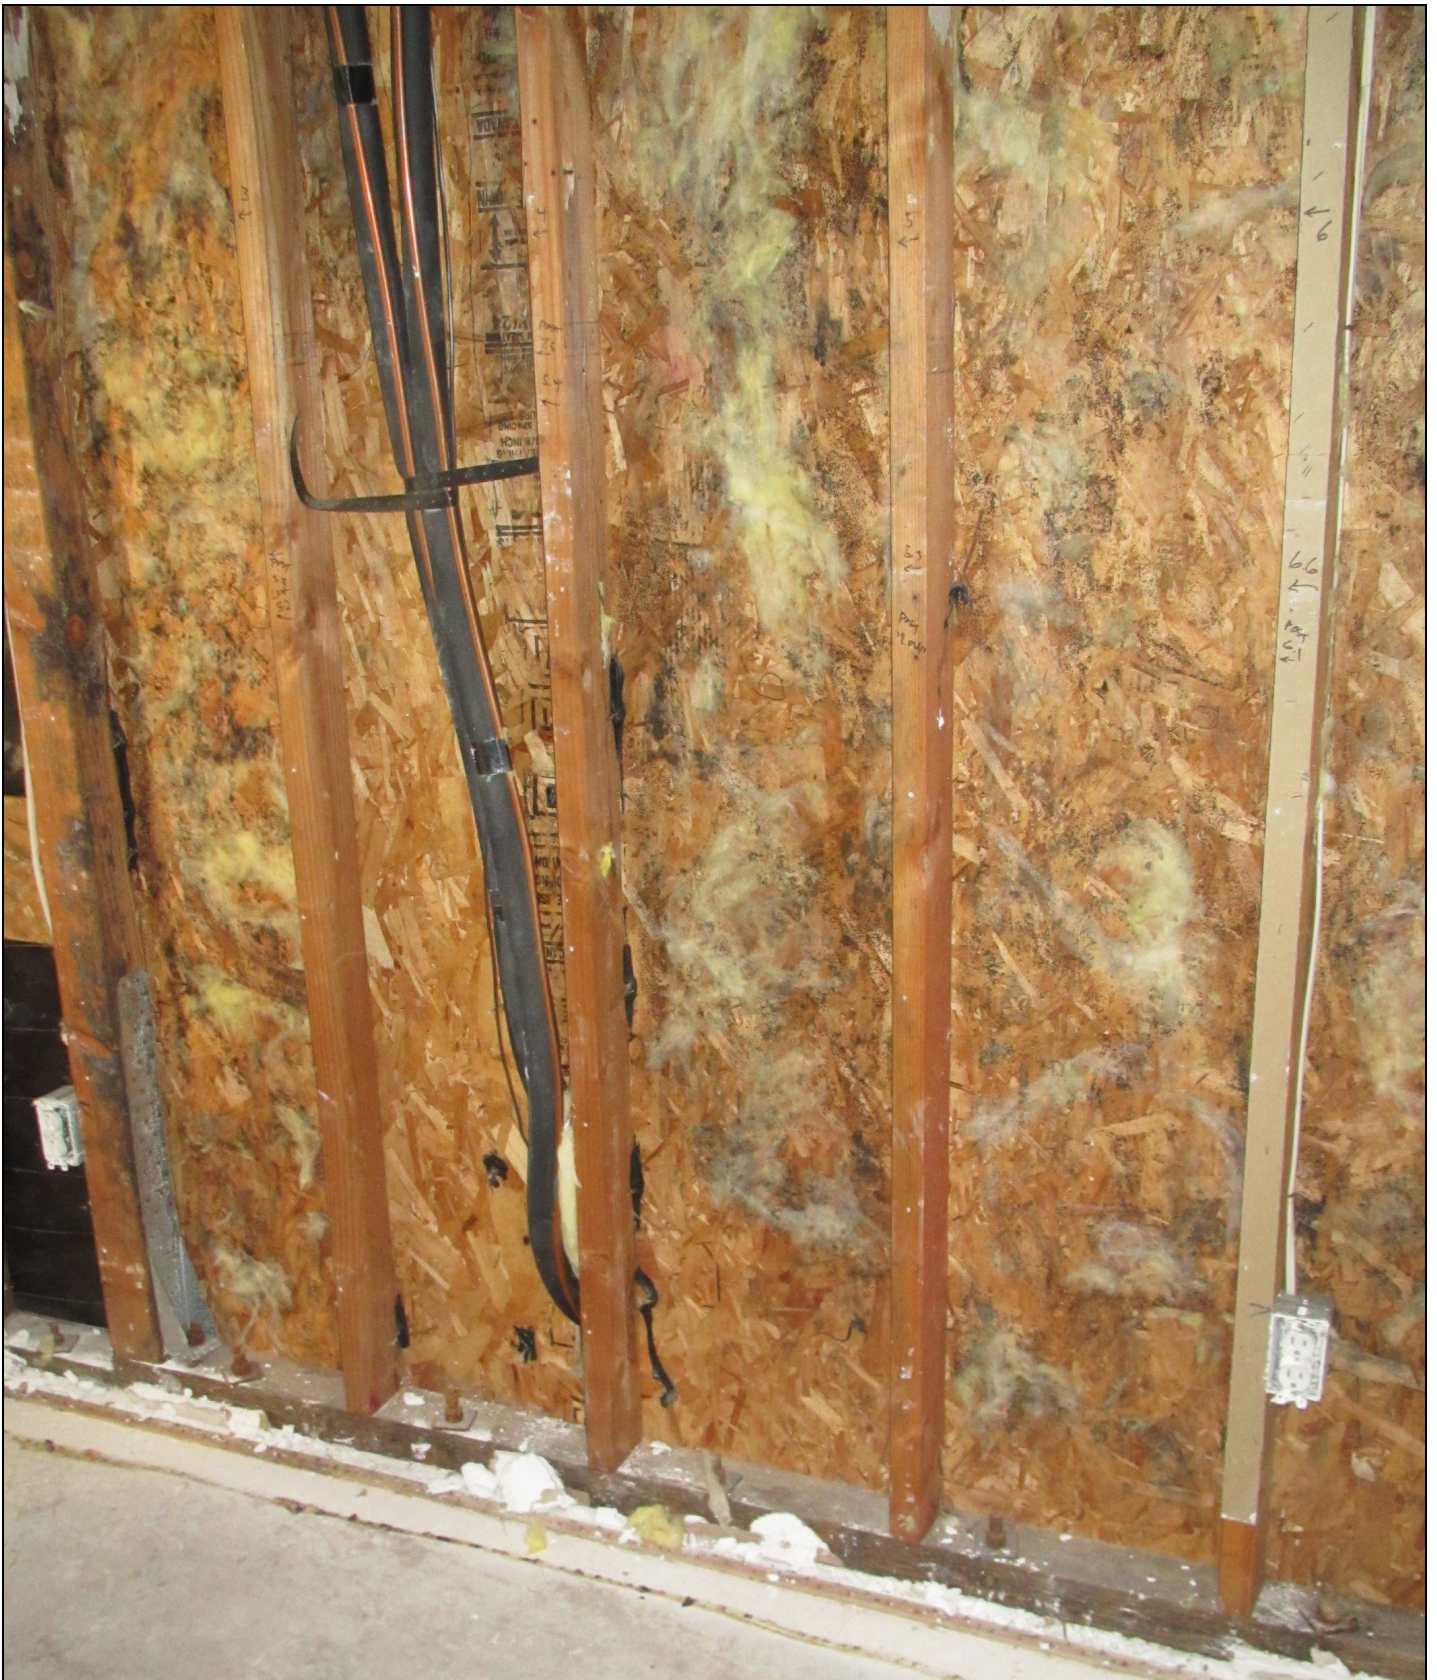
Photo 4 – At this wall, the remnants of batt insulation stuck to the inside face of the OSB sheathing indicate it has been uniformly wet at times – except at the one stud bay warmed by AC heating lines (serving both the lower and upper units).

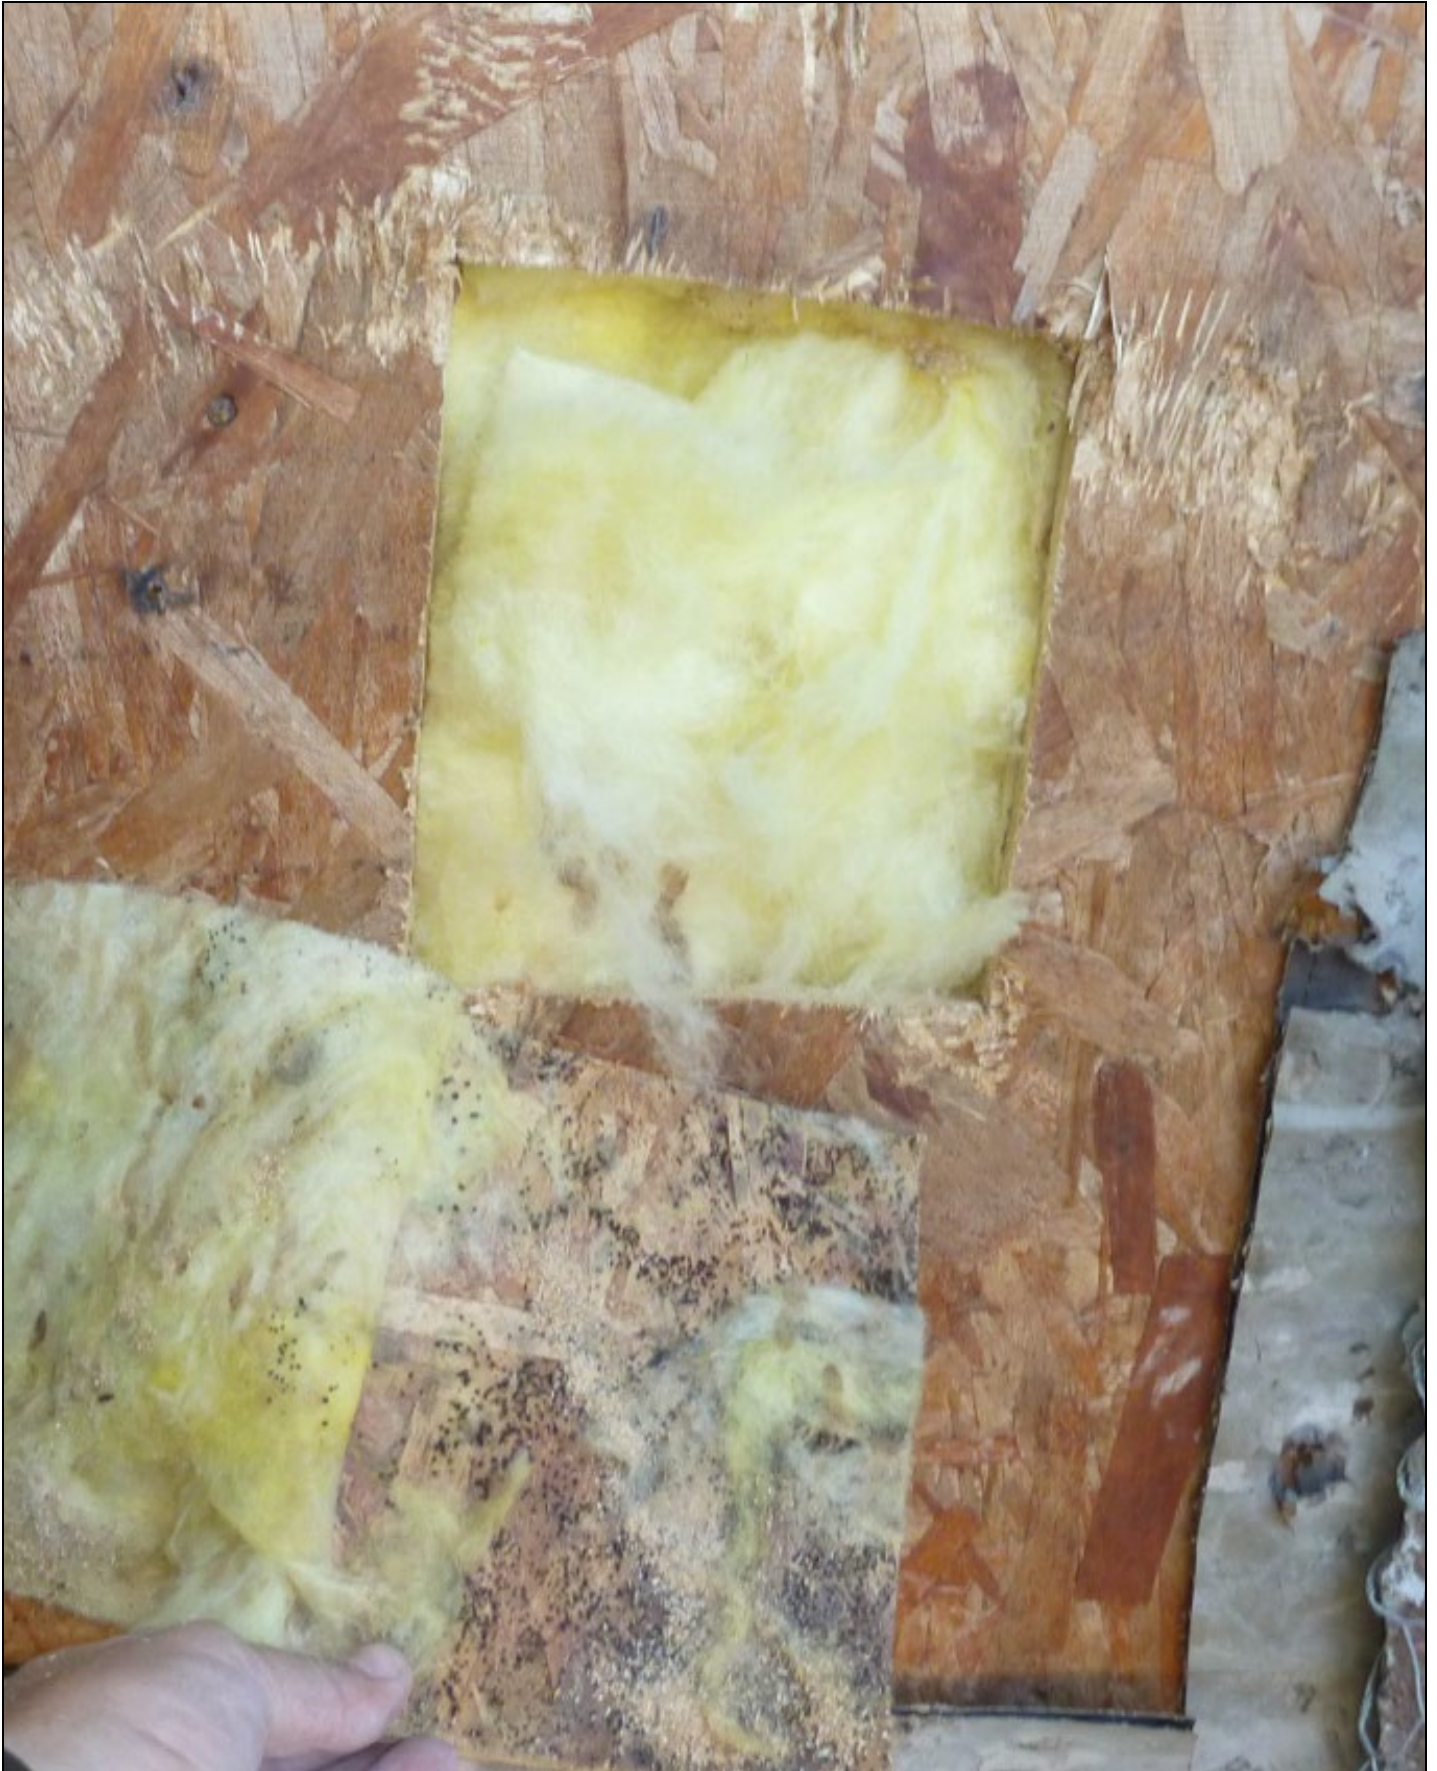
Photo 7 – The clean and bright exterior face of this OSB sheathing shows no evidence of rainwater leakage.

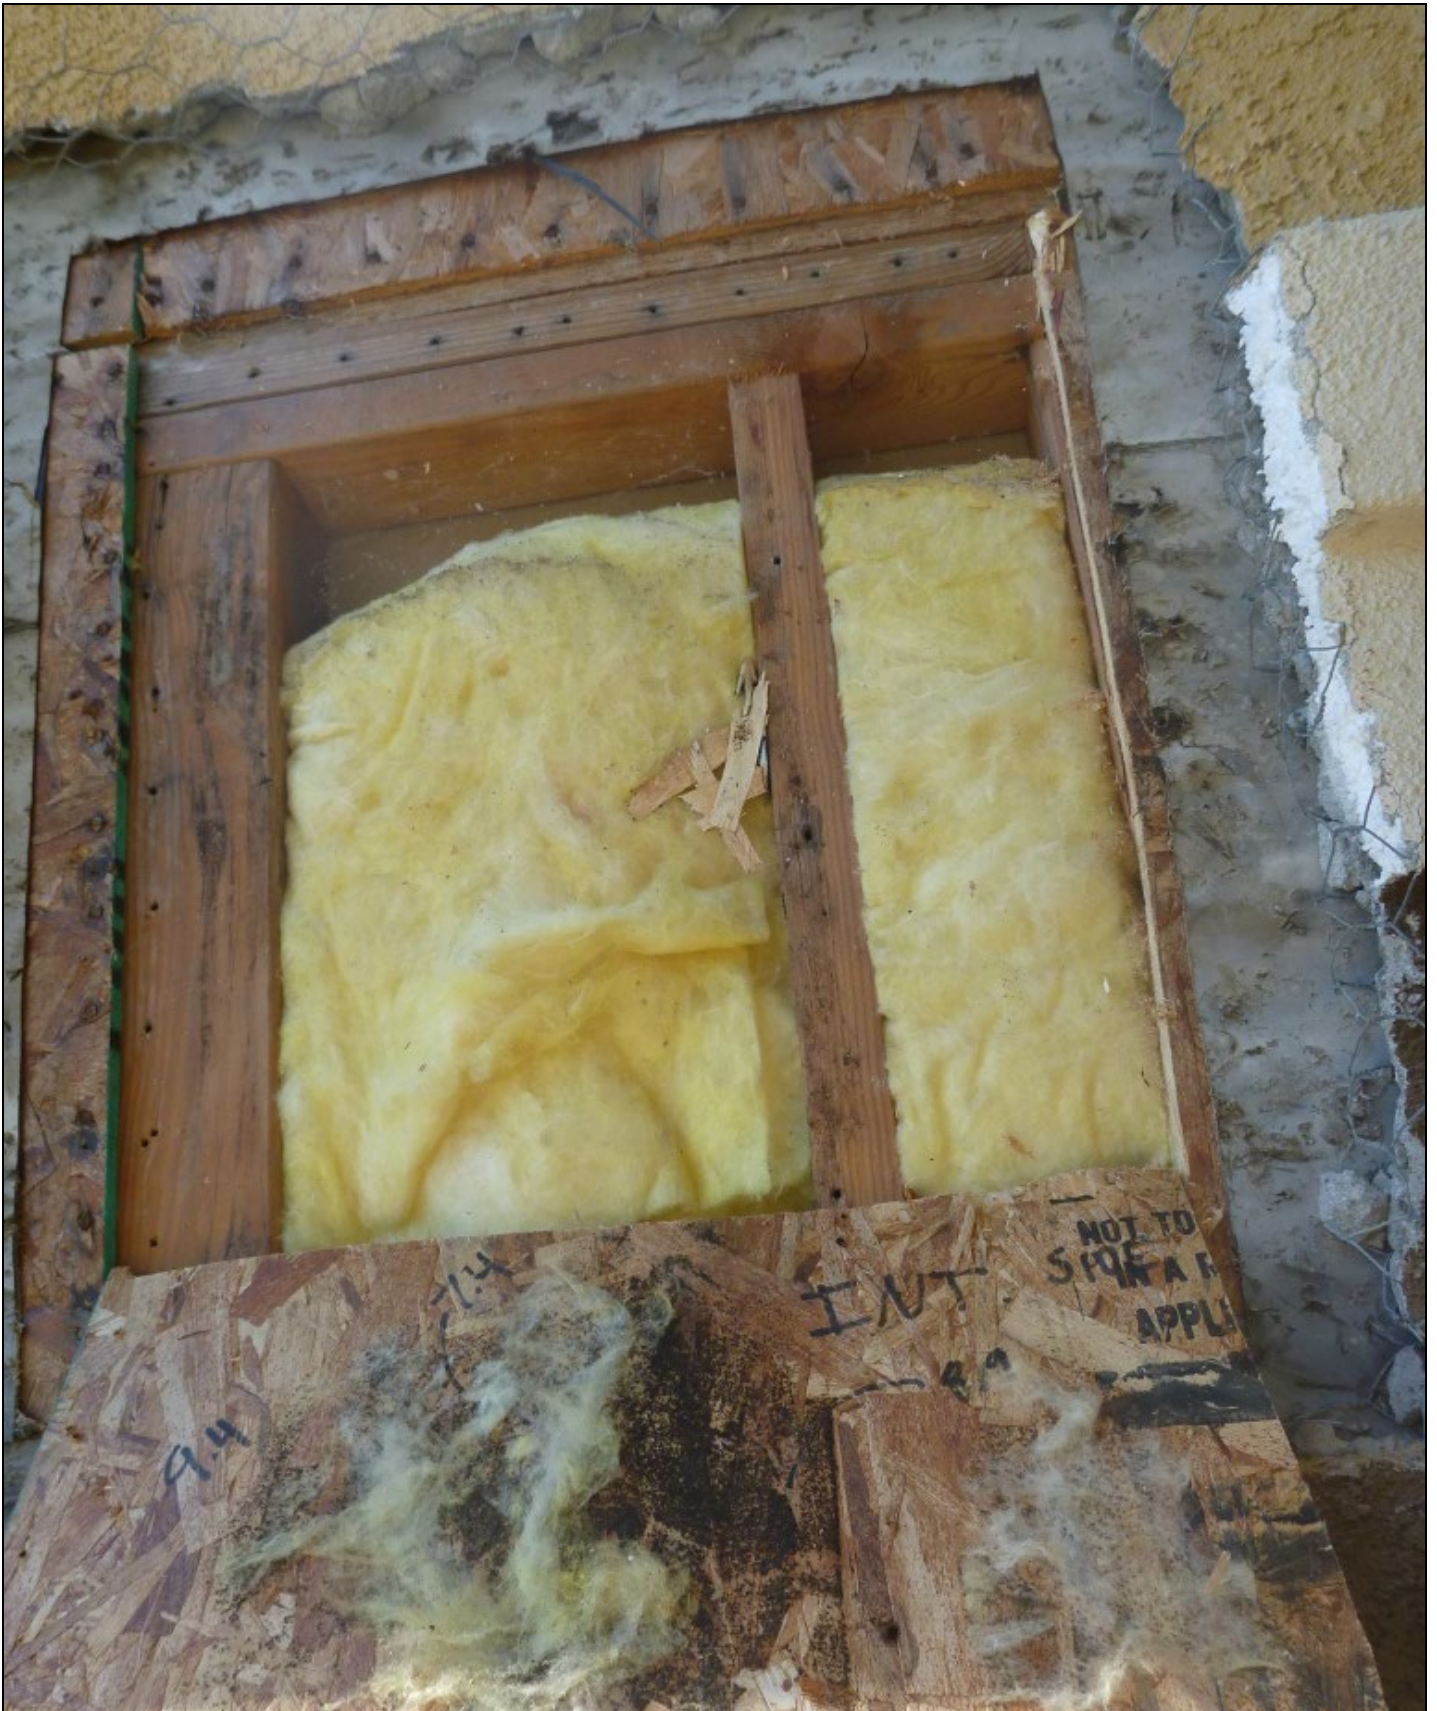
Photo 8 – Even though this OSB was dry (9.4% and 7.4% moisture content) during our summer testing, the close correlation between the fungal growth and sticky insulation is indicative of cold-weather condensation.

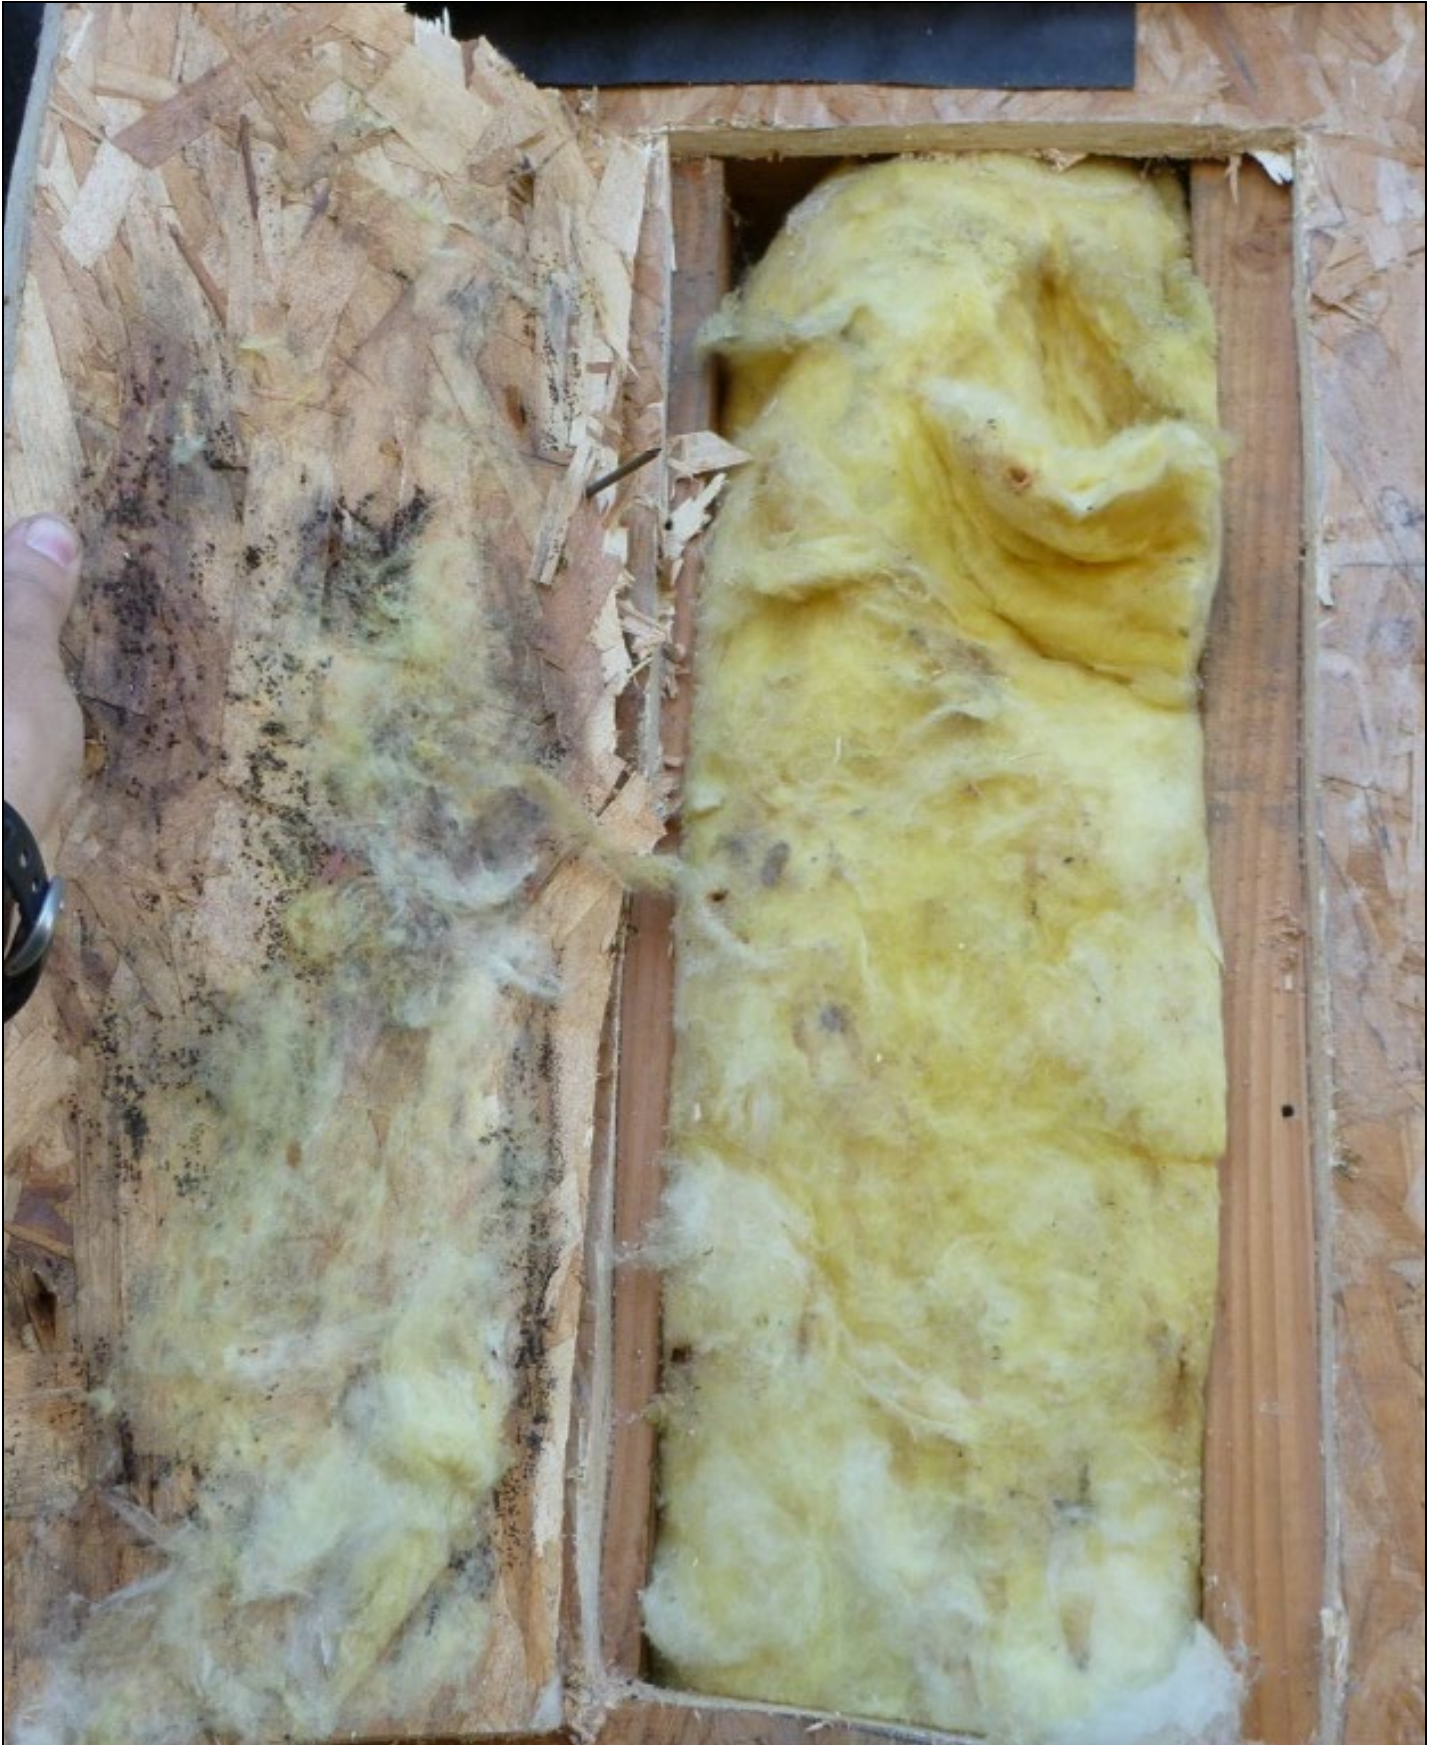
Photo 9 (same test location as Photo 10) – Fungal growth and sticky insulation remnants at inner face of the OSB panel. Again, the clean and bright exterior face of this sheathing shows no evidence of rainwater leakage.

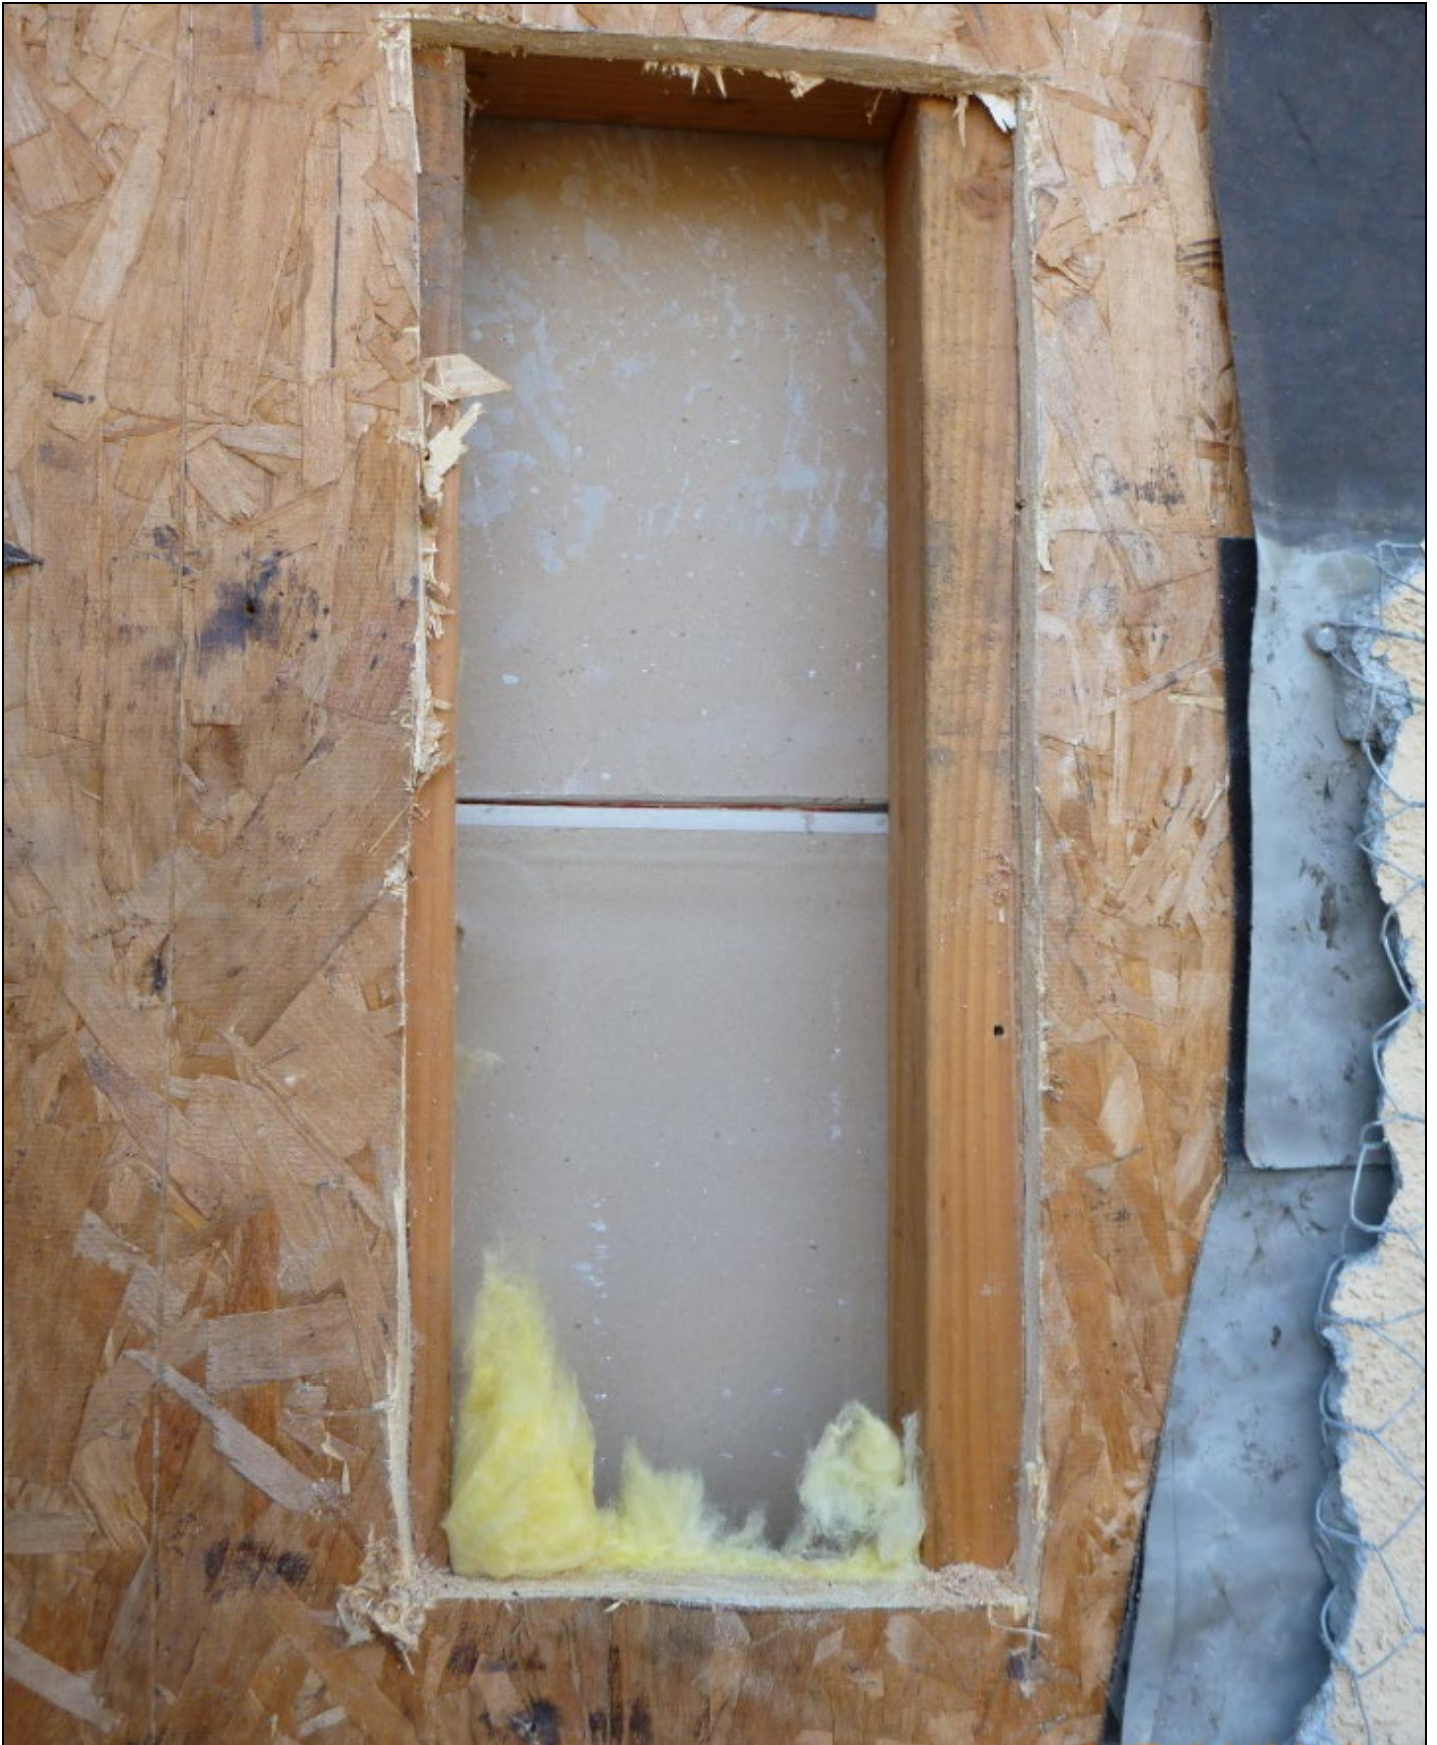
Photo 10 (same test location as Photo 9) – Because this joint was not fire-taped, contrary to code, pressurized air from the semi-conditioned interstitial space can flow (via Dr. Lstiburek’s “wind tunnel” effect) down into the cold-in-winter stud bays.

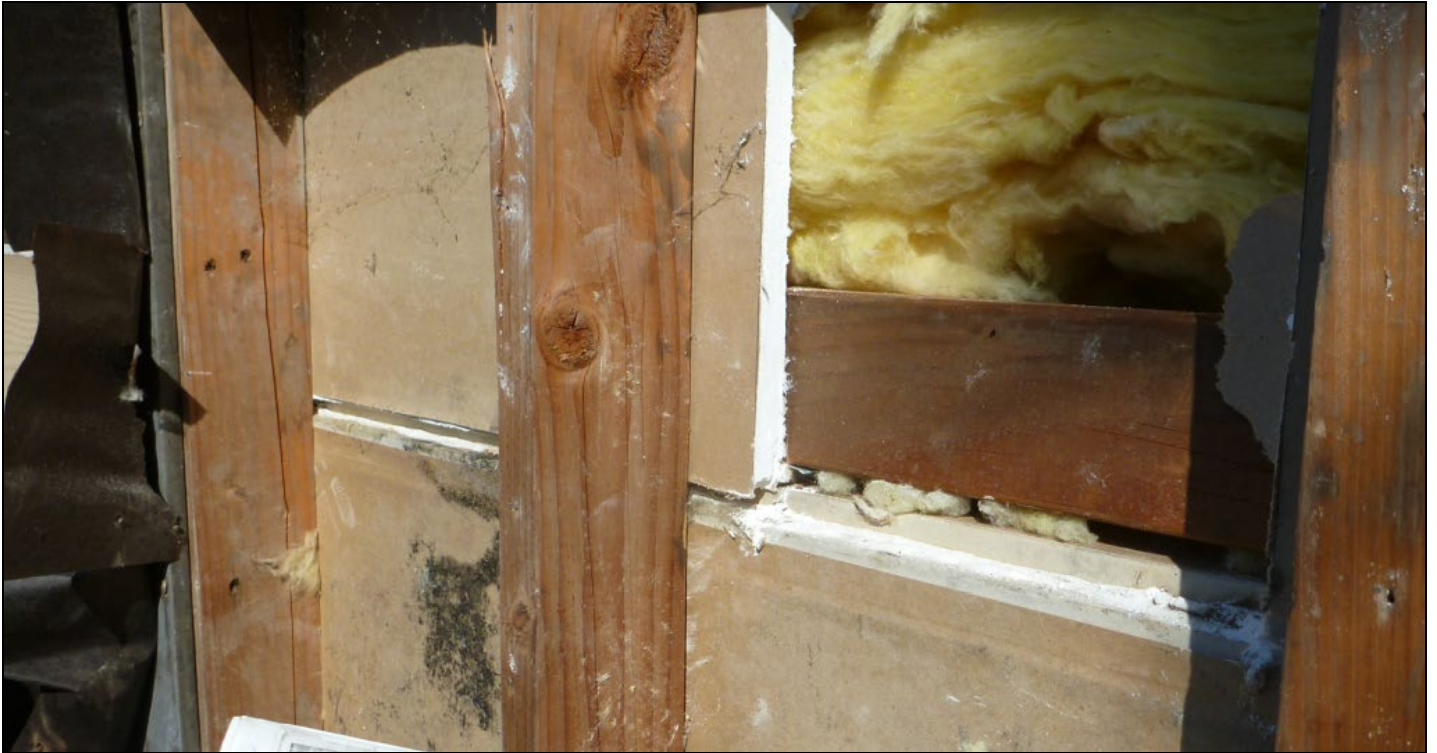
Photo 11 – The failure to fire-tape these joints between the interstitial spaces and the units below negated the code-mandated air pressure boundary. The resulting “wind-tunnel” effect produced condensation and fungal growth at the OSB panels.

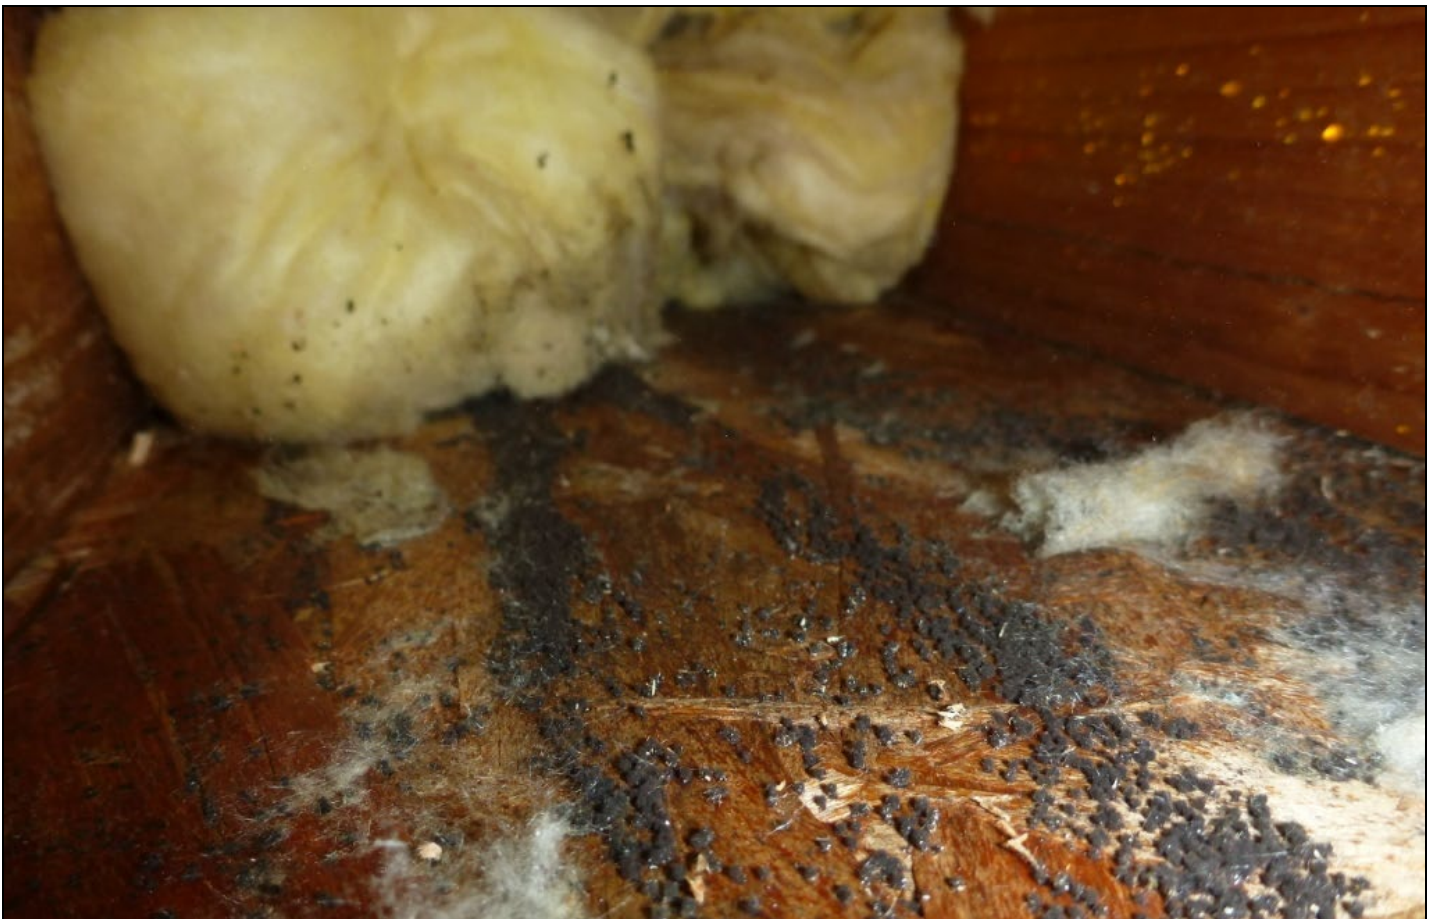
Photo 12 – Prolific fungal growth at “condensation plane” at inner face of the OSB sheathing.
