Case Studies: The Perils of Poor Rim Joist Closure Construction

Introduction

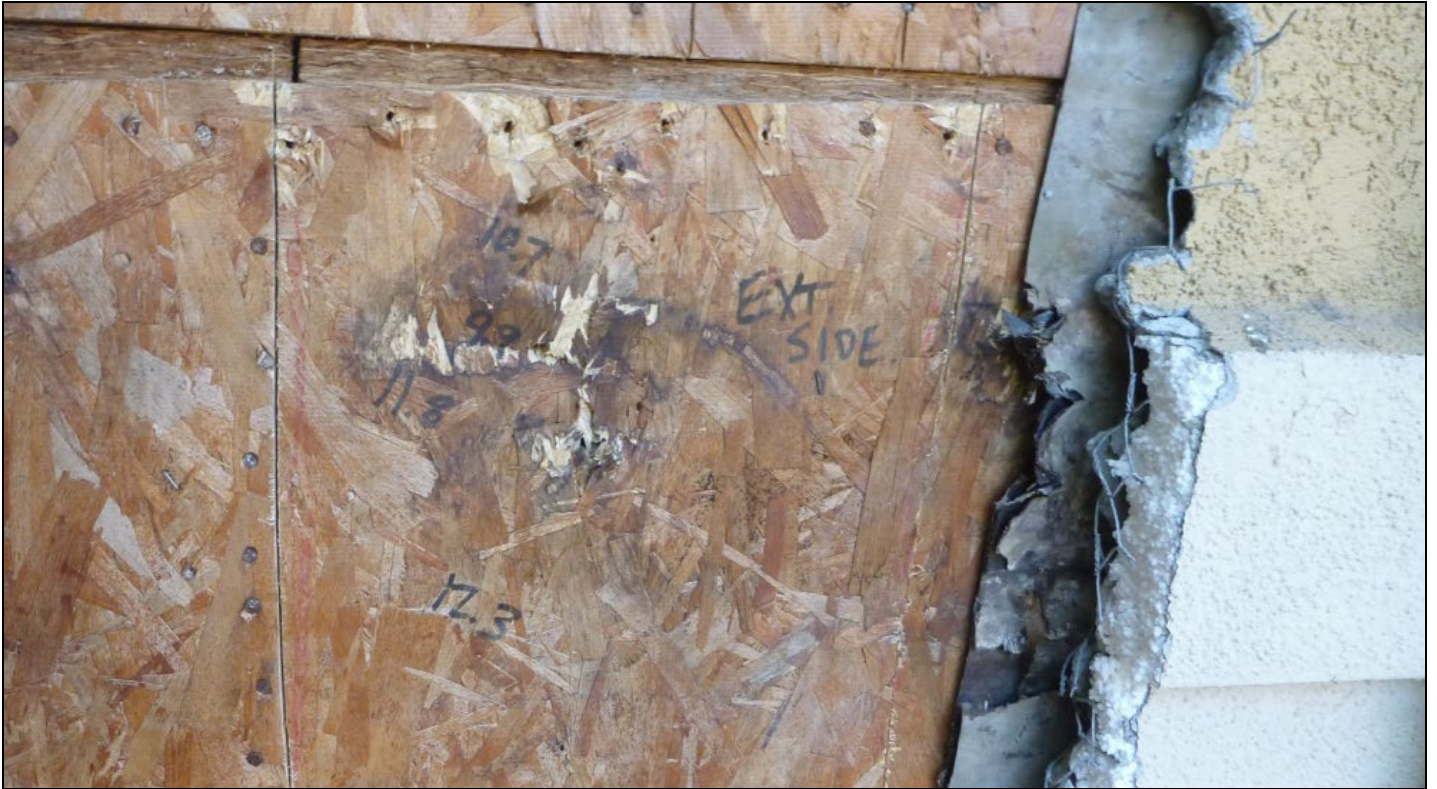
Photo 13 – While some evidence of moisture damage was found at the exterior face of this OSB sheathing, which spans the rim, far greater degradation was found at the interior face (compare with Photo 14).

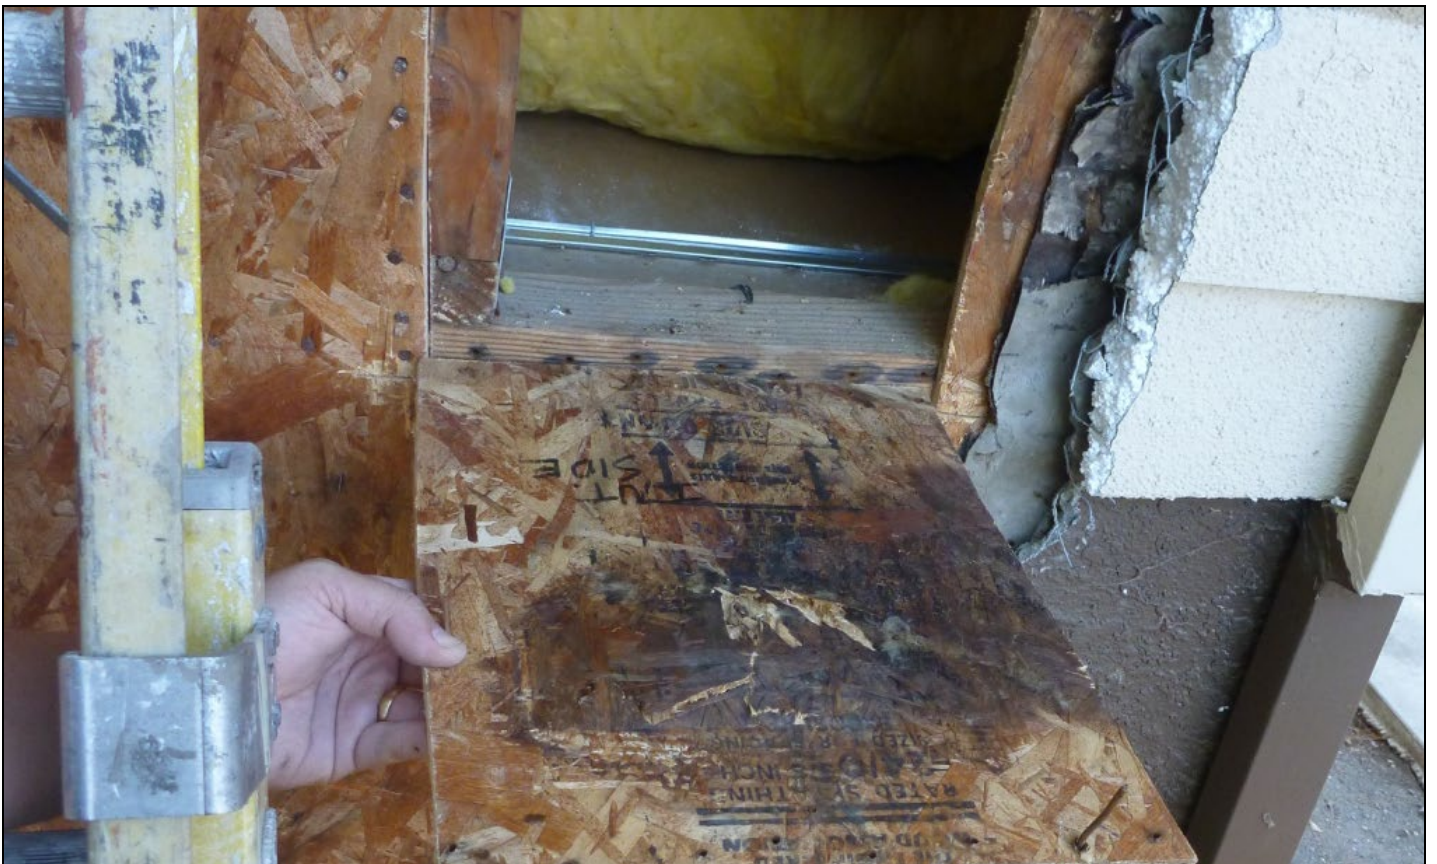
Photo 14 – In conjunction with Photo 13, this photograph conclusively demonstrates the deleterious effects of vapor condensation at the interface between the semi-conditioned interstitial air and the cold-in-winter rim.

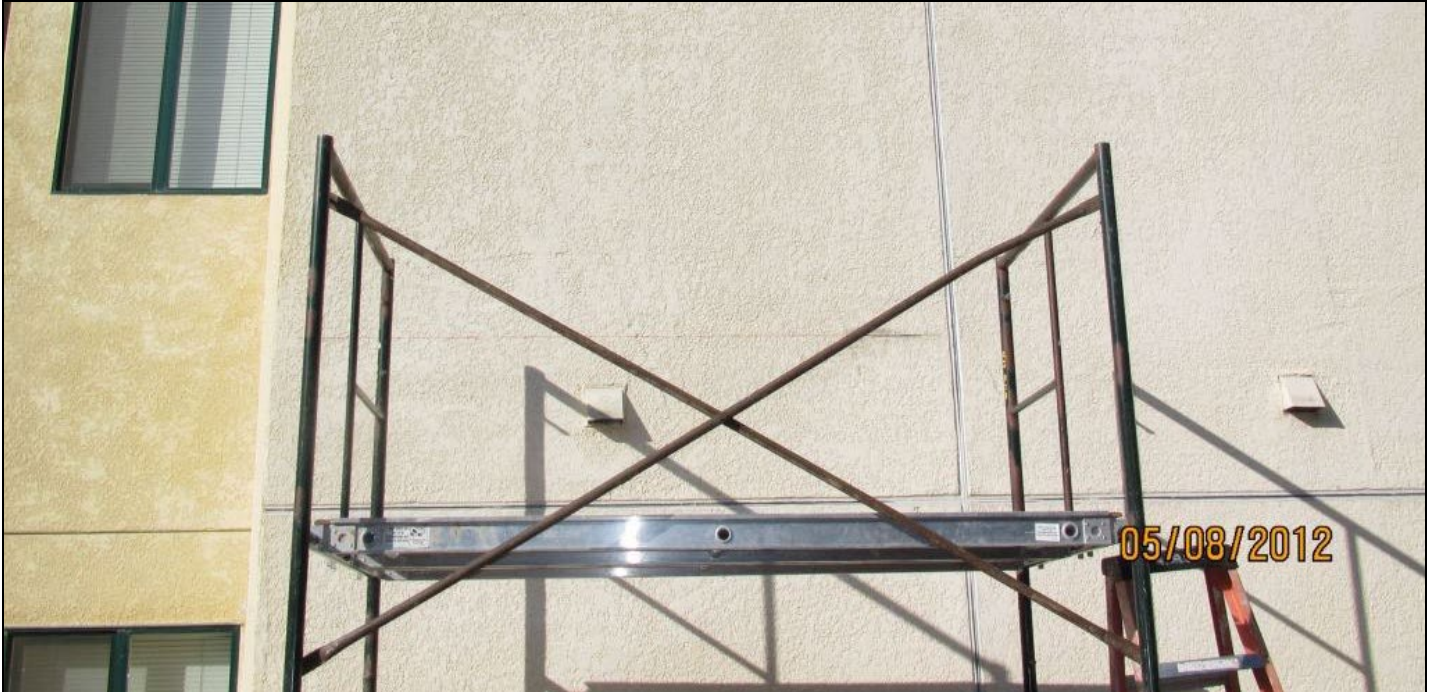
Photo 15 – Our team’s inspection in 2012 of this stucco-clad wall revealed no evidence of rainwater infiltration or decay.

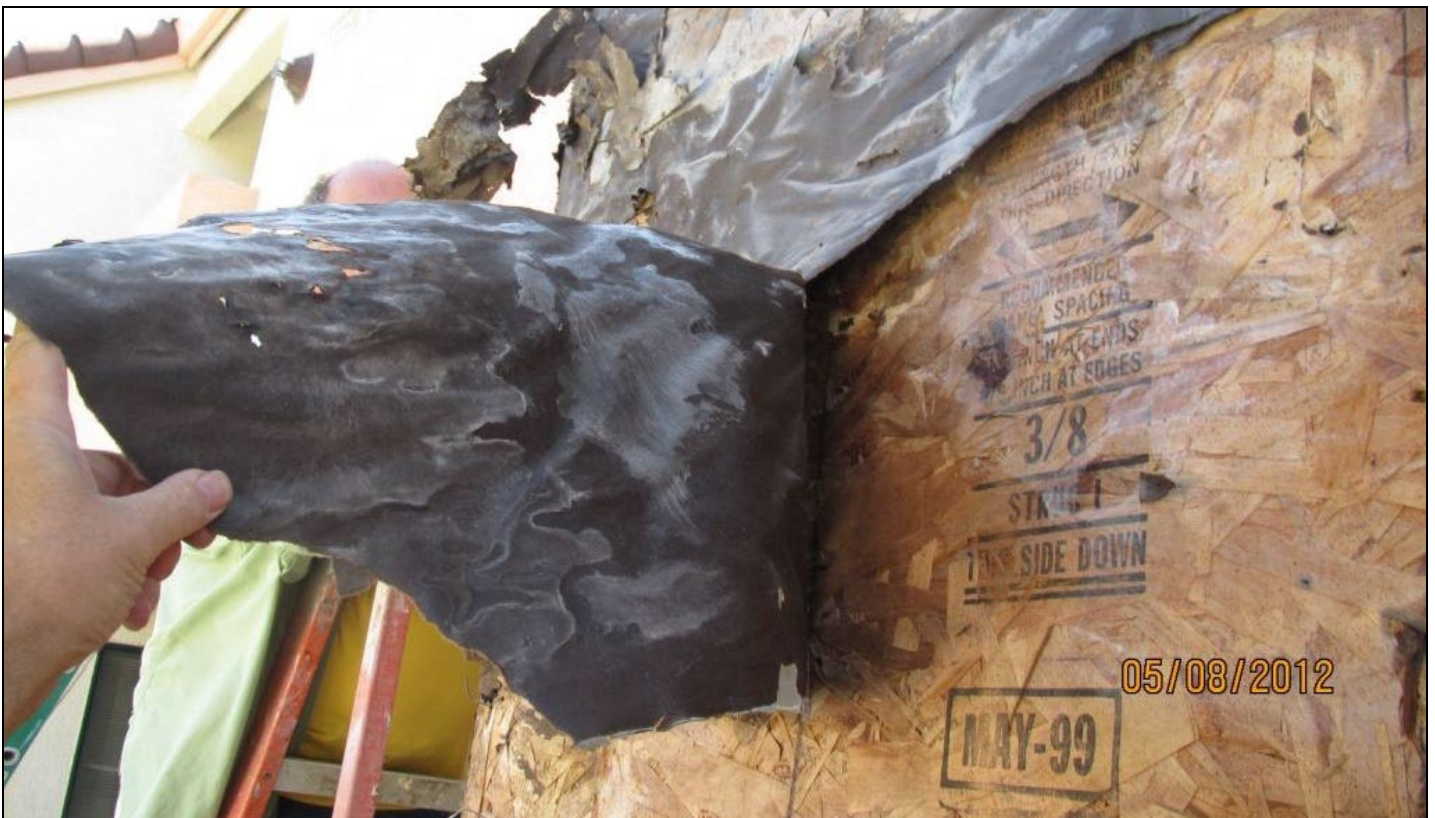
Photo 16 – However, despite the dry sunny weather, free moisture still was found *behind* the asphaltic building paper.

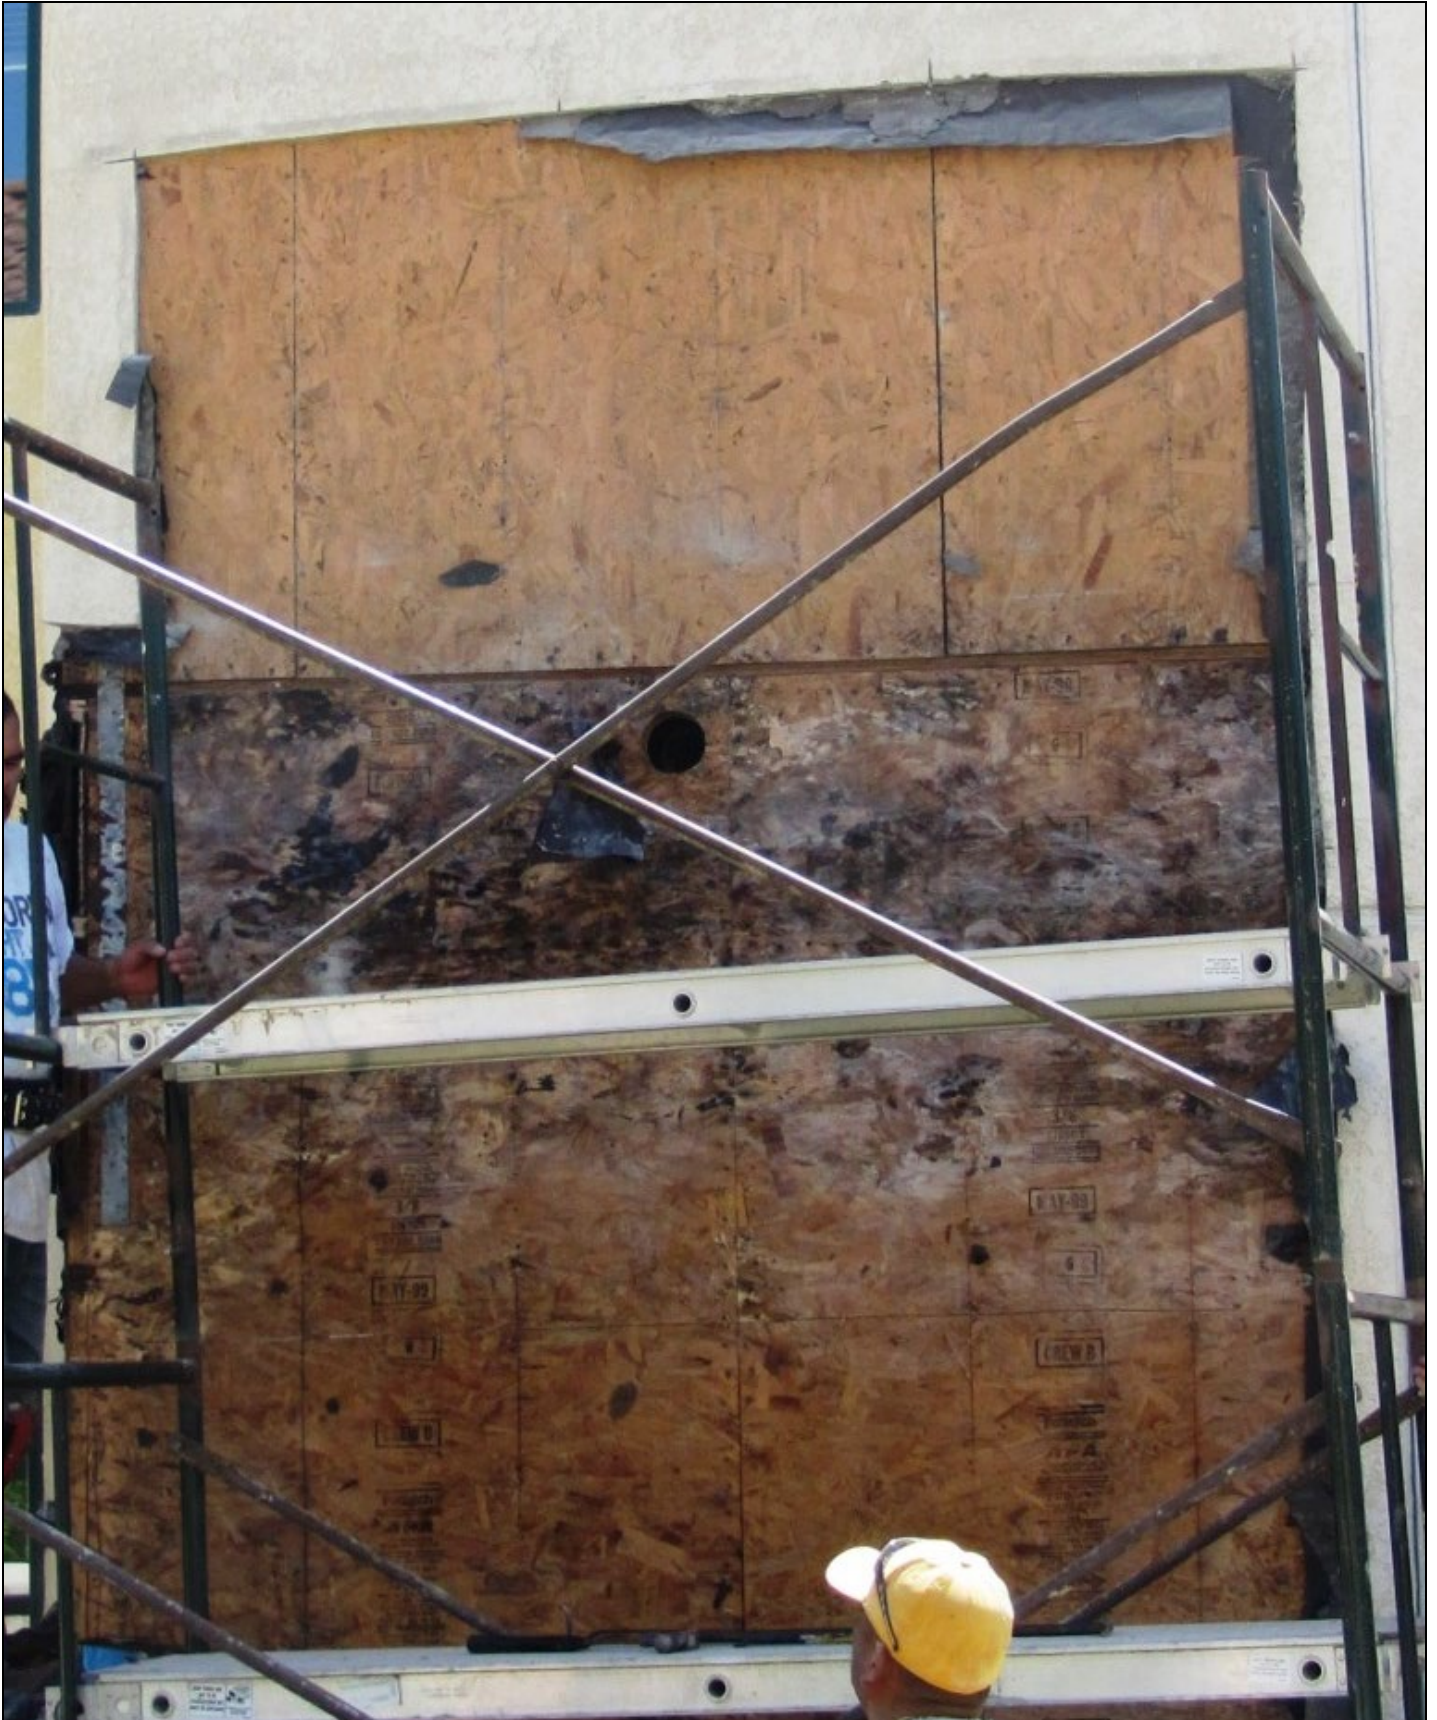
Photo 17 – Further, the deterioration and damage were most severe where these OSB shear panels spanned the 18-inch-high interstitial joist bays above the first-floor apartments.

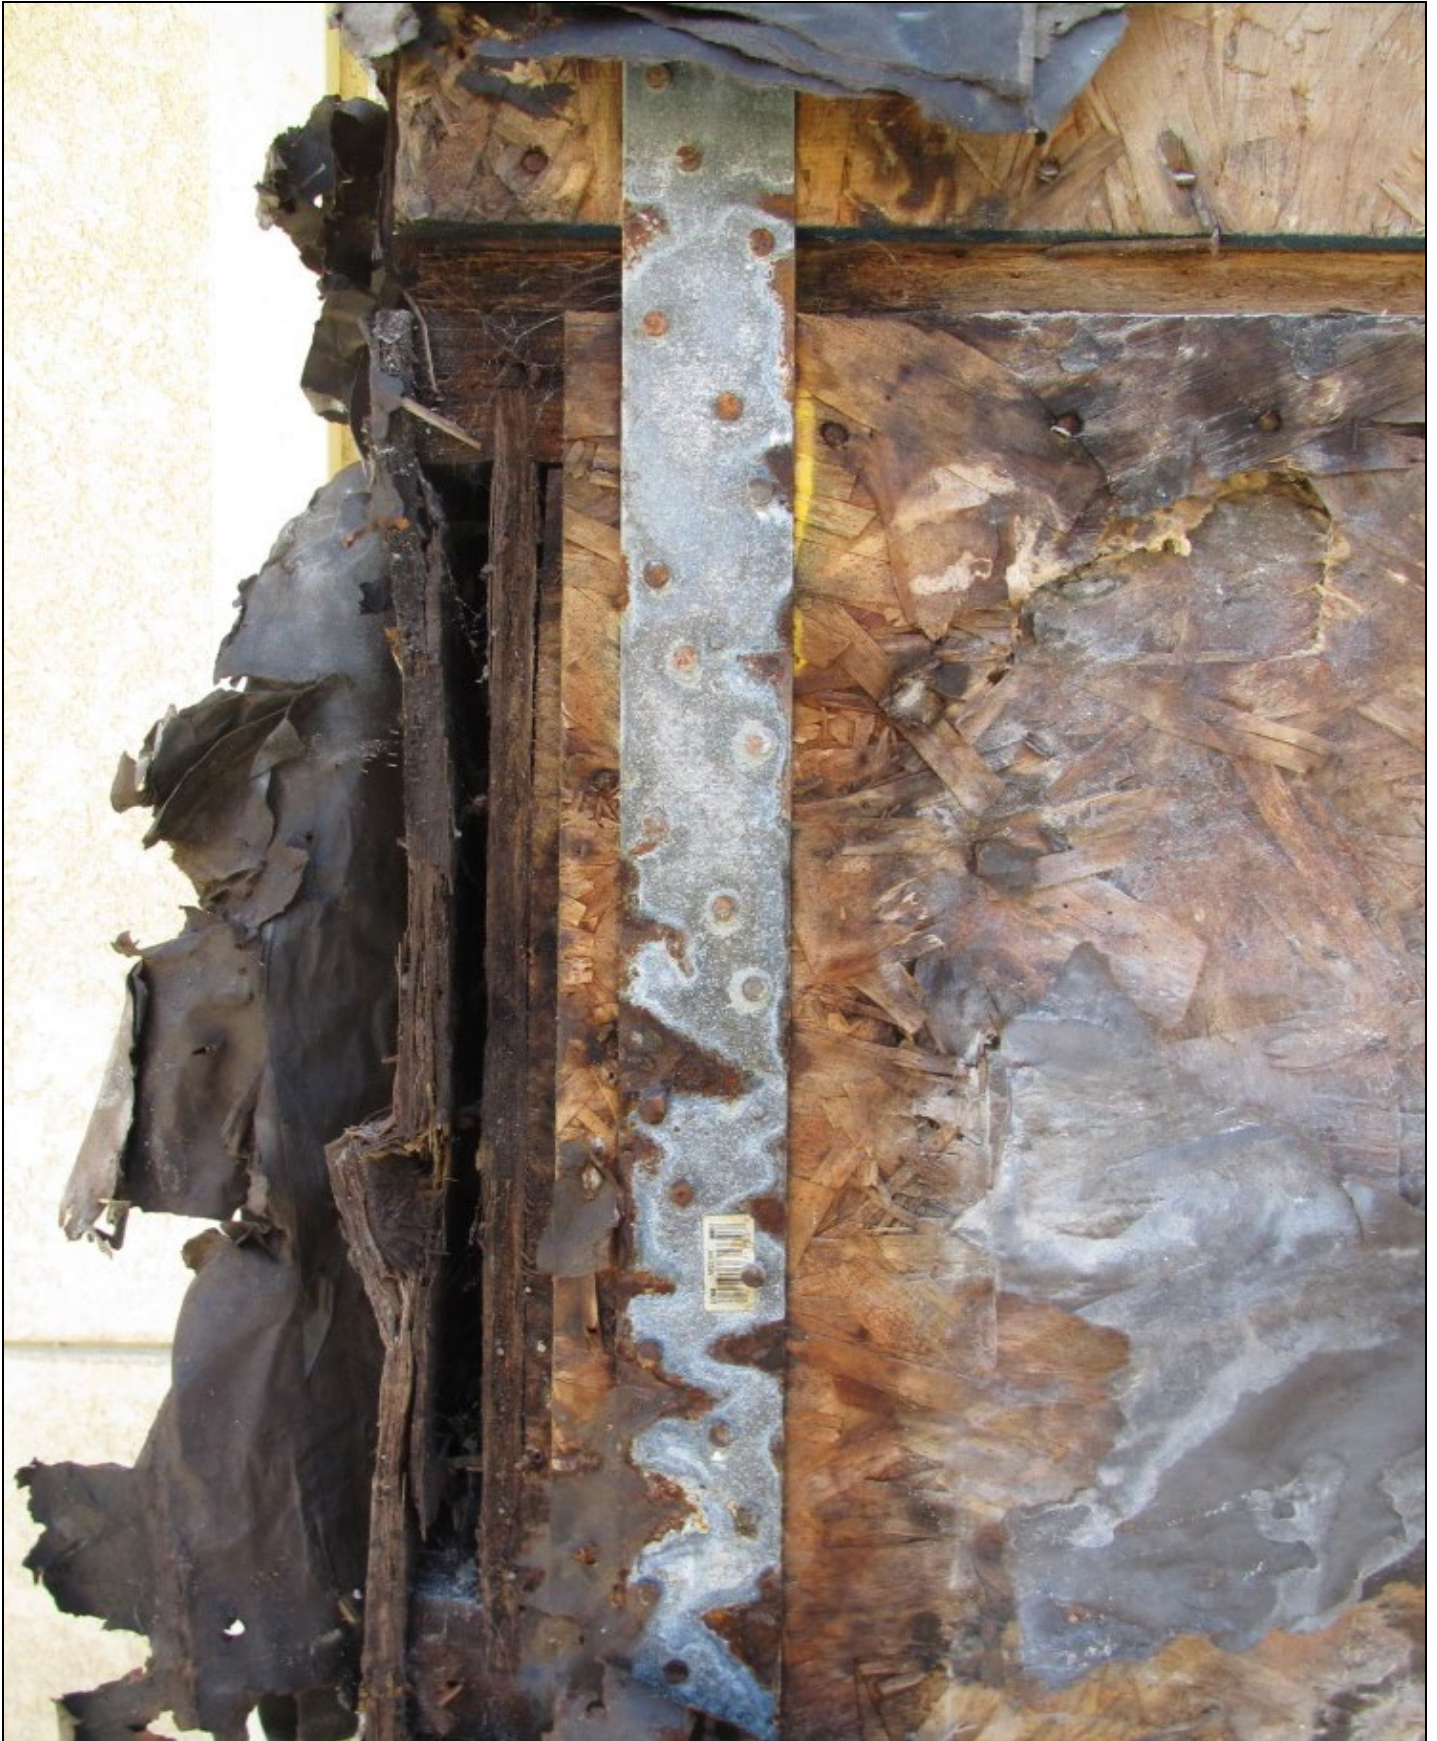
Photo 18 – In particular, the exposed deterioration and damage corresponded to poor rim joist enclosure practices.

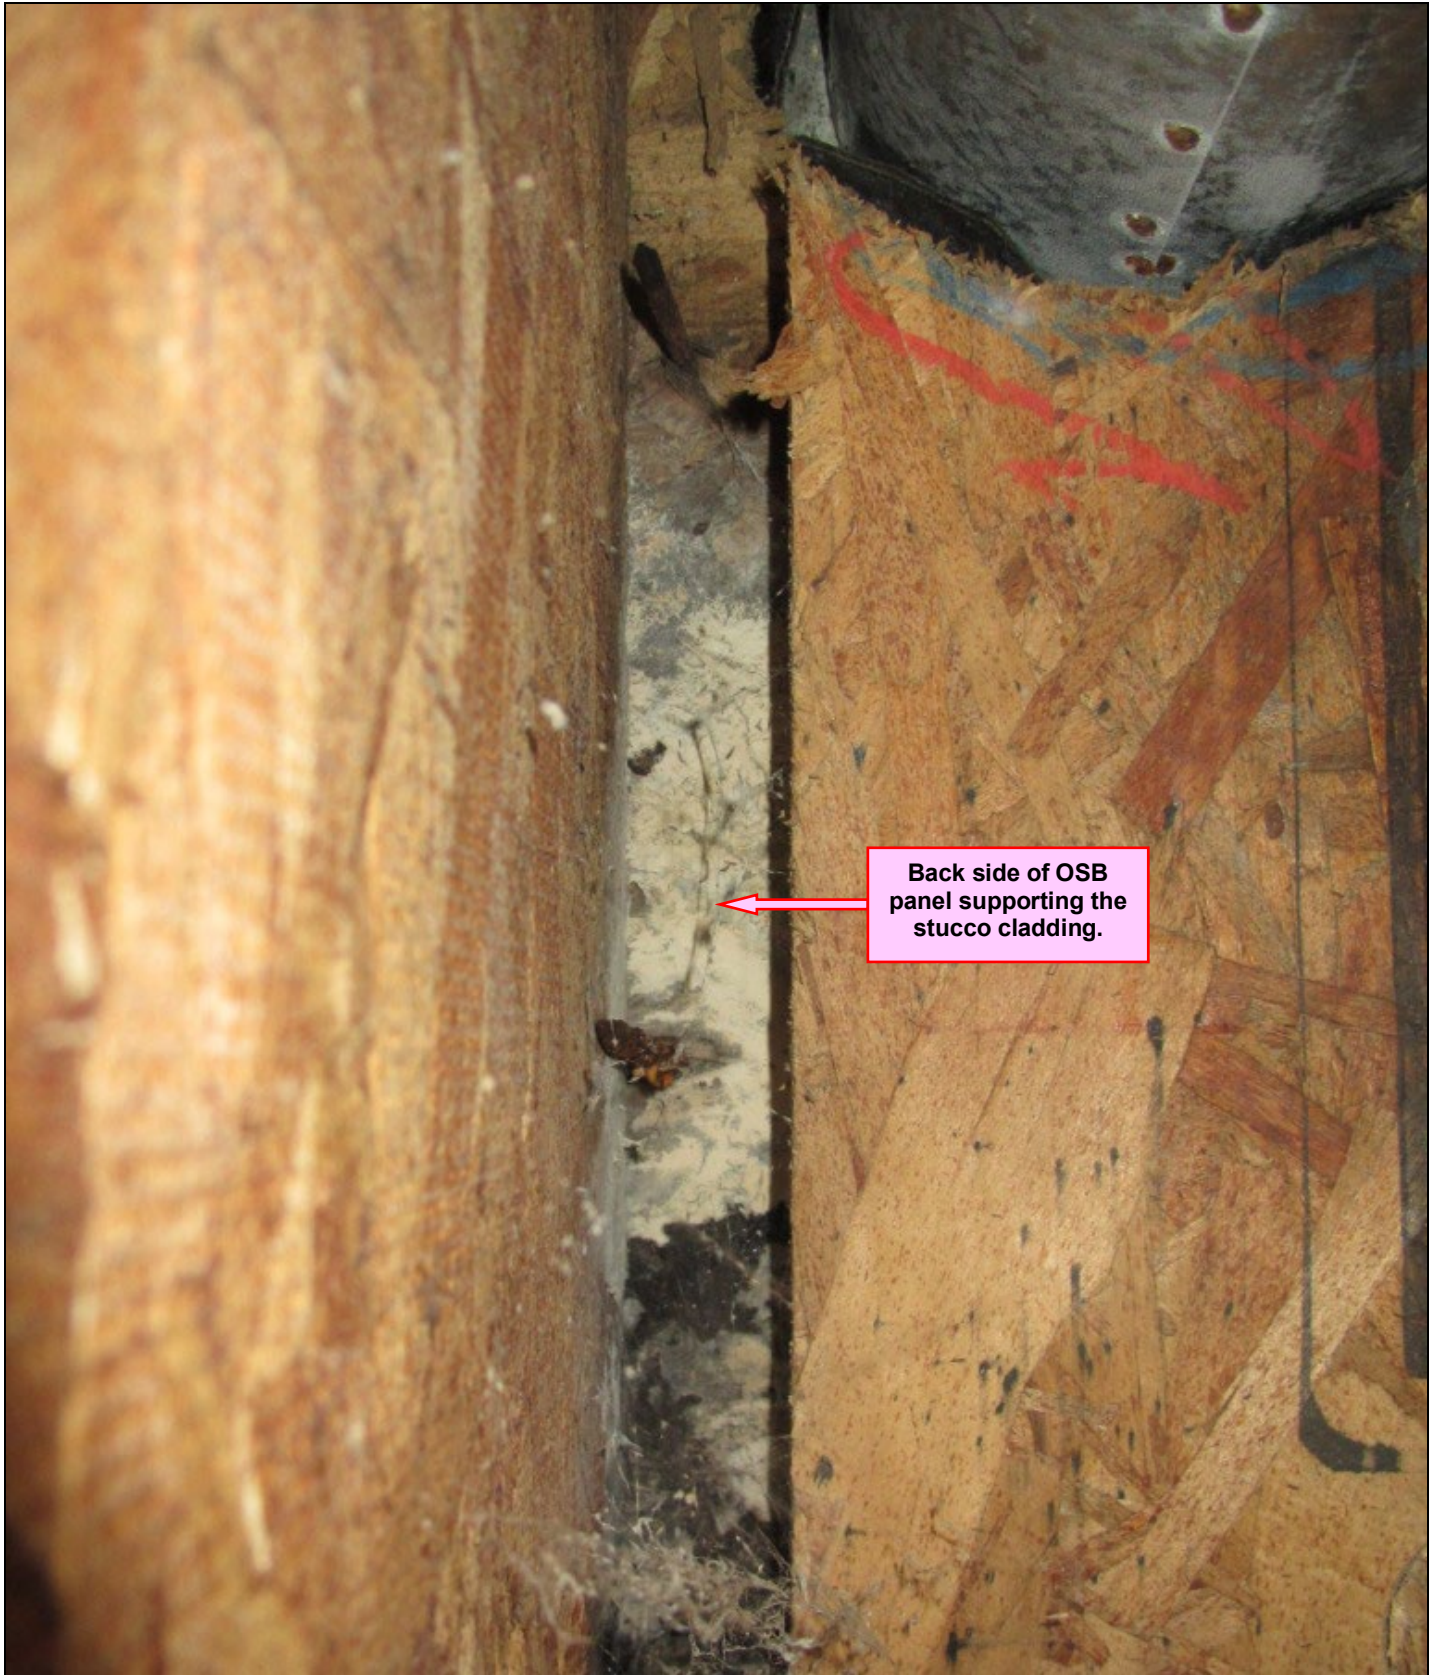
Photo 19 – At all buildings, the most severe damage was found at the poorly enclosed rim joists at the interstitial space above the first-floor apartments.

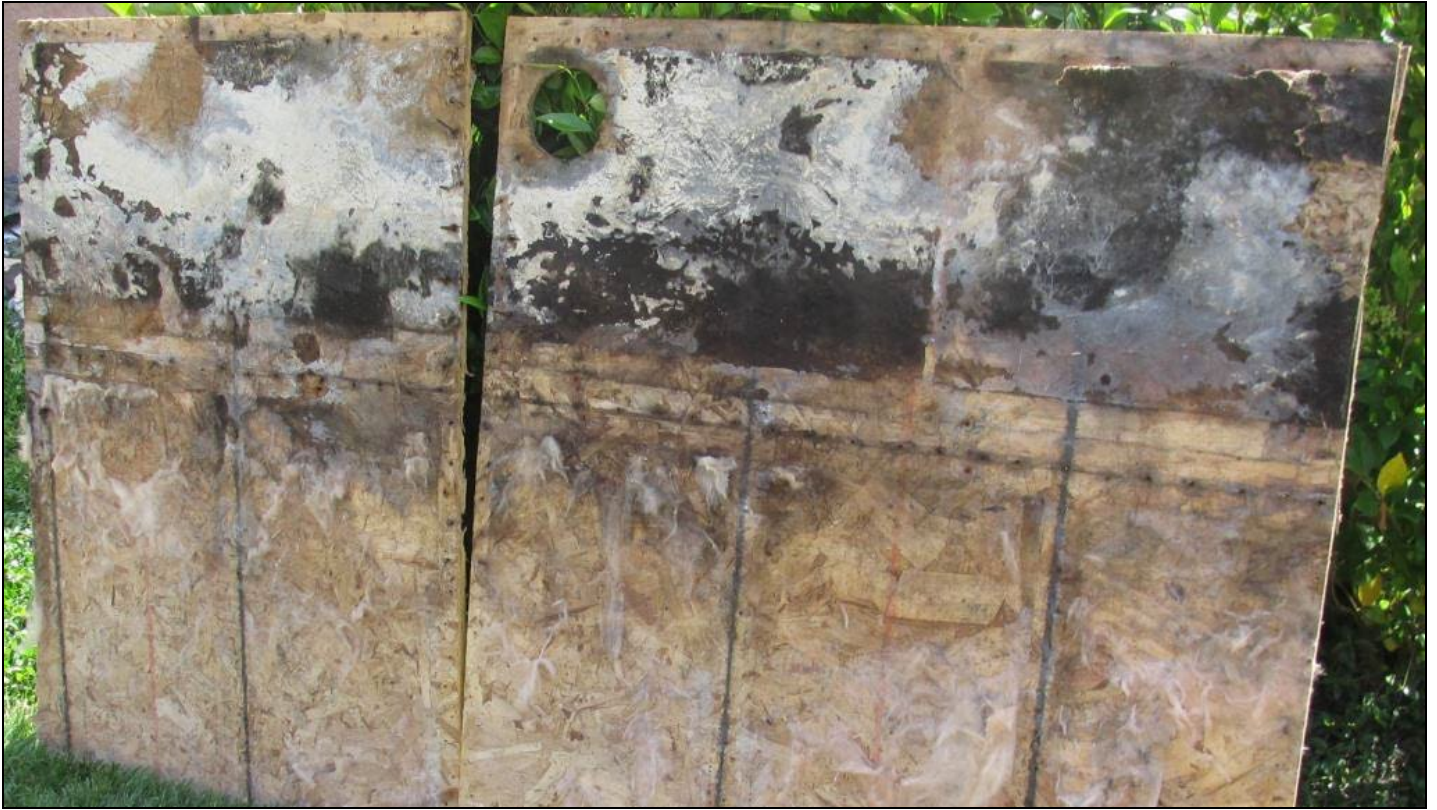
Photo 20 – Extensive fungal growth was observed at the *interior* face of the OSB panels where they spanned the poorly enclosed interstitial joist bays.
